# Accident at Russia's Biggest Hydroelectric Plant

Sayano-Shushenskaya – August 17, 2009

## Sayano-Shushenskaya hydro-electric power plant

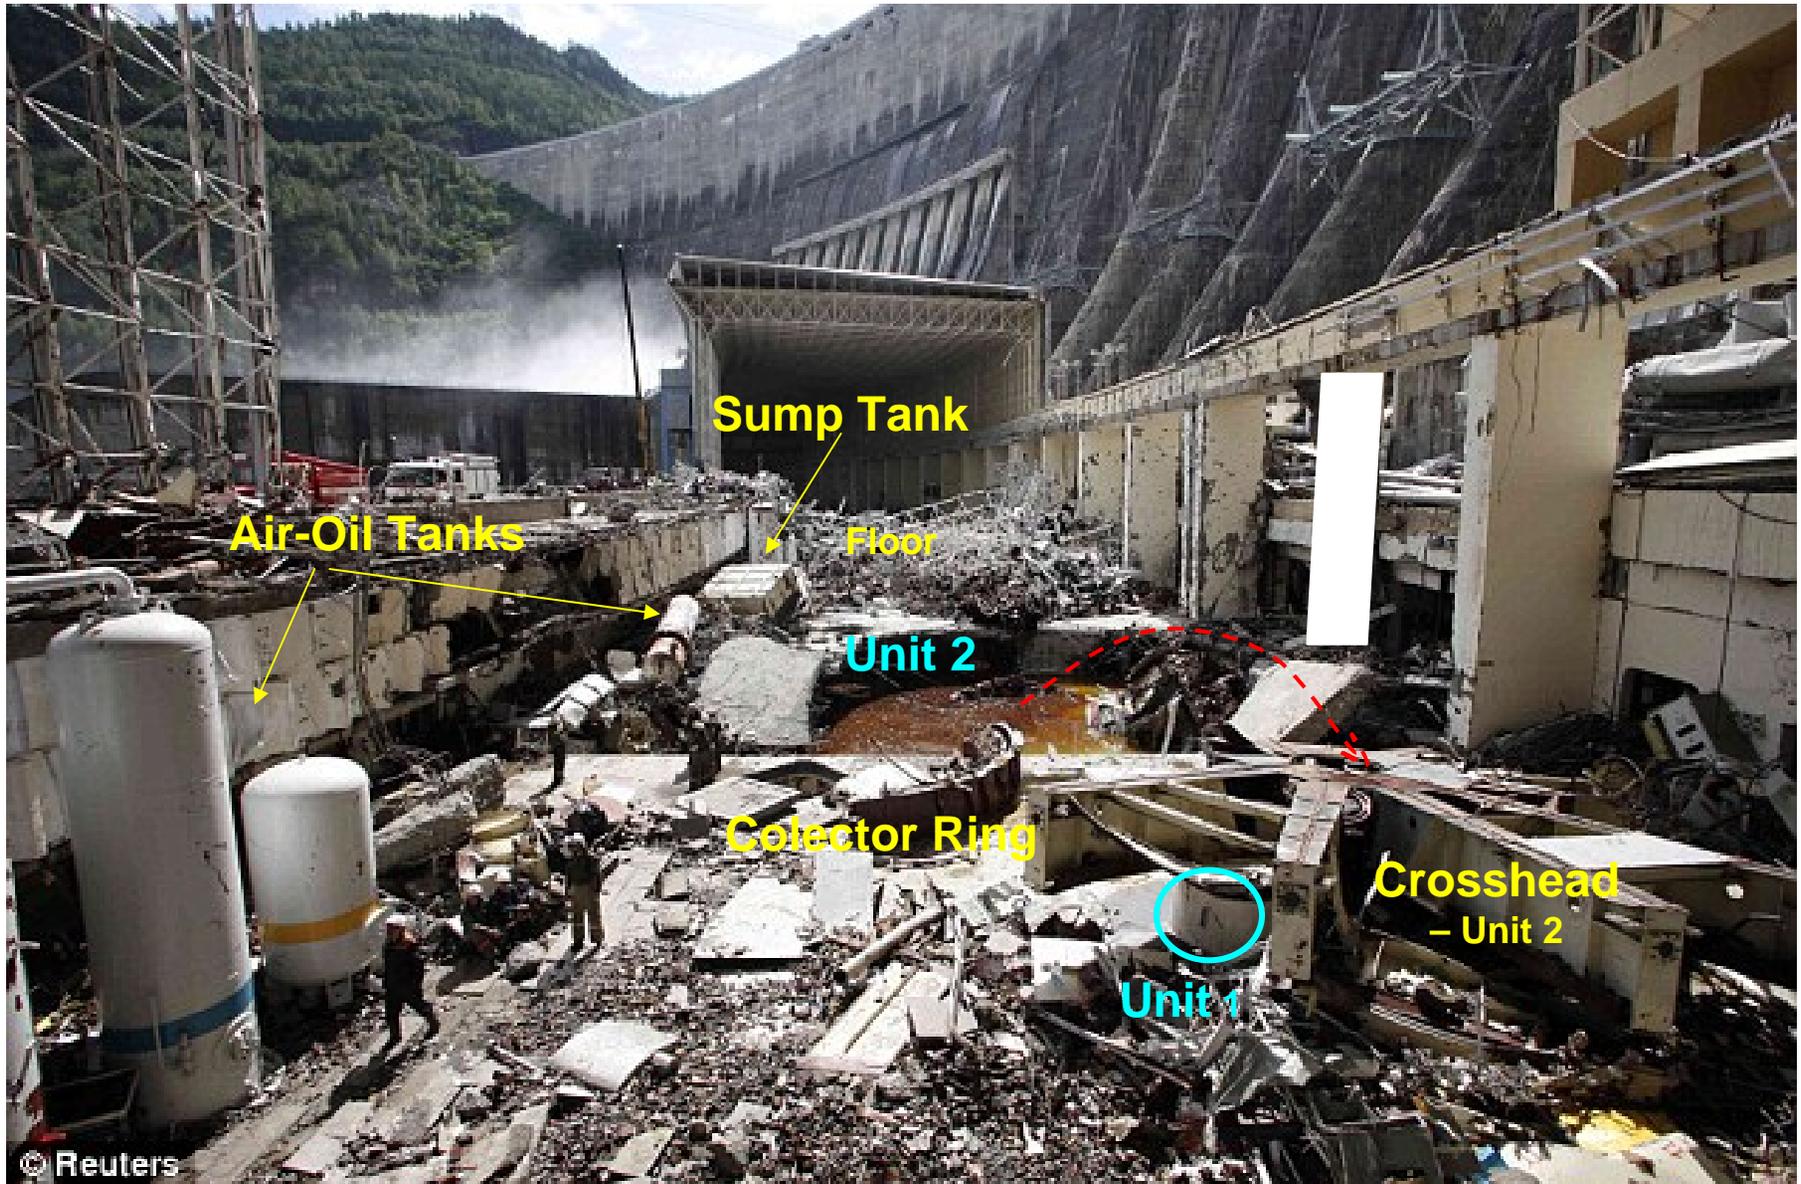
*Generator floor*

# After the Accident

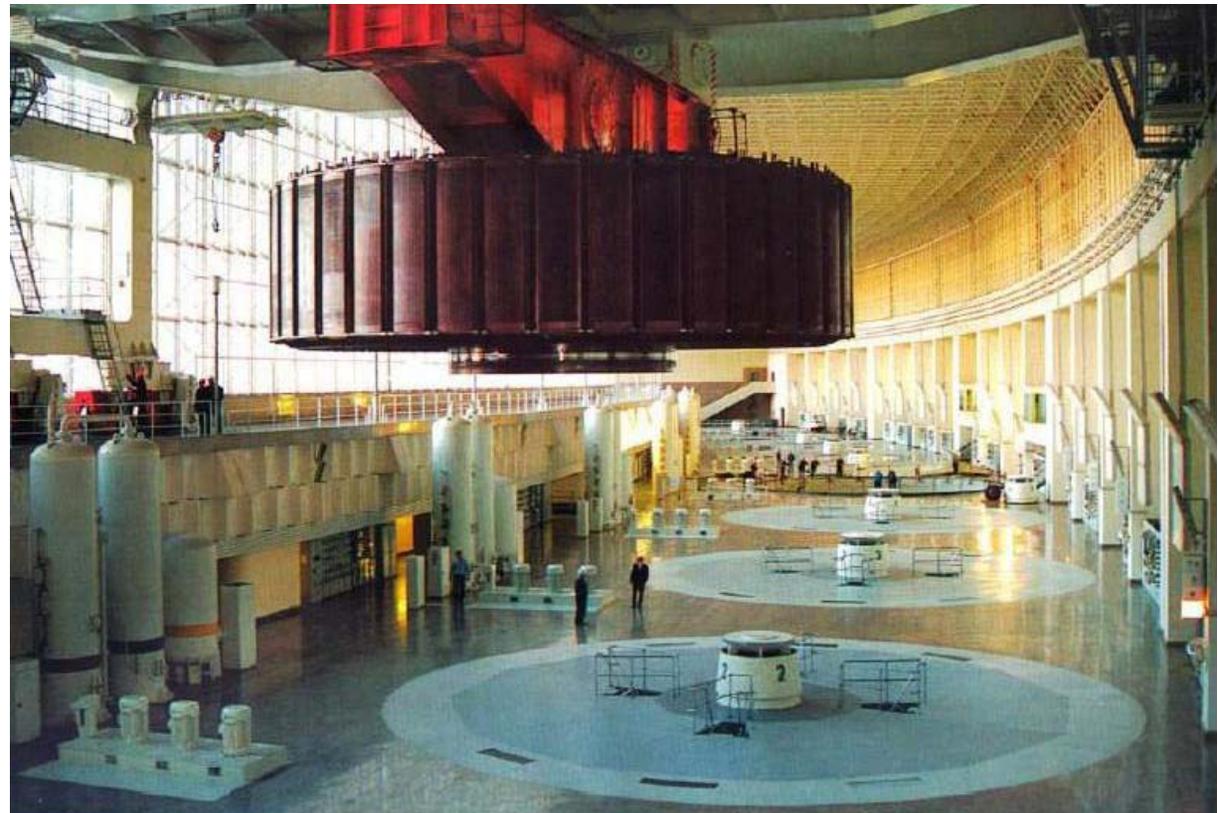
## **Before the accident, Unit 2 was in non-recommended Zone six times, swinging from 170 to 600-MW**

Evaluation of vibration was not present in operational decisions in the control room.

New vibration control of Unit 2 was installed in 2009 but it was out of service.

Grid regulation was accompanied by very high vibration at Unit 2.

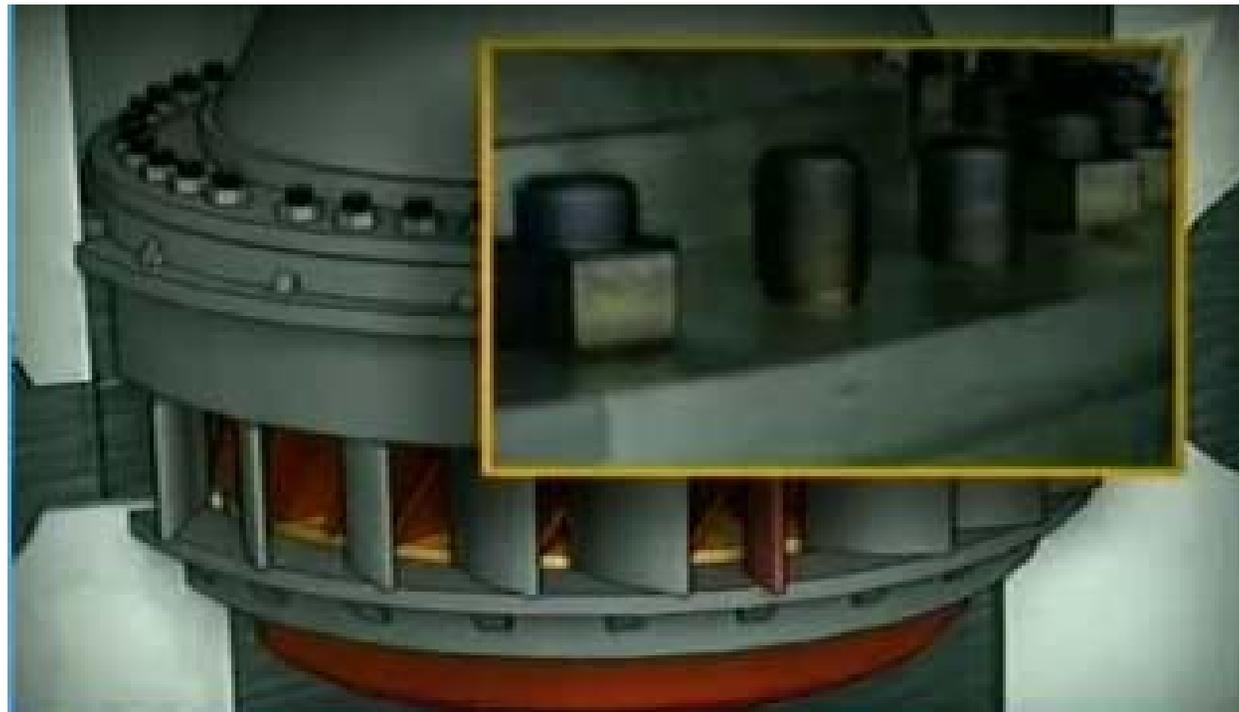
13 min  
before the  
accident,  
the limit of  
vibration  
was  
exceeded  
3.75 times

At the time of the accident, the limit of vibration was exceeded 5.25 times.

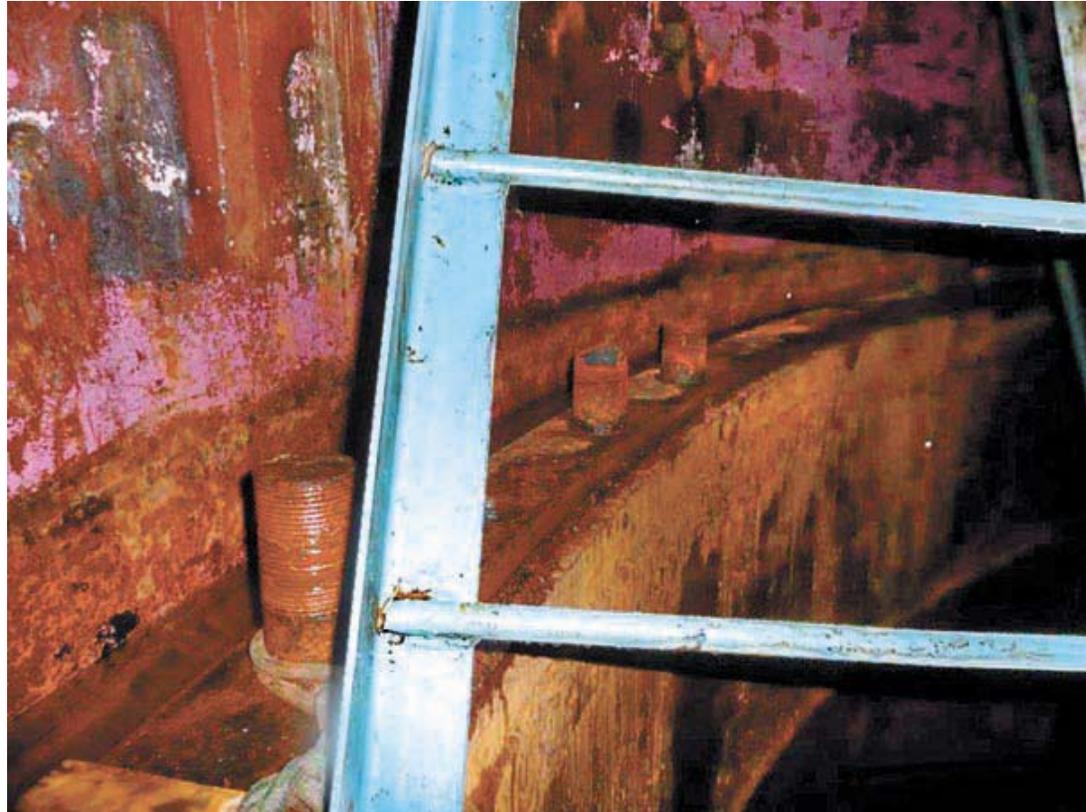
## Turbine Cover Bolts Failed on Unit 2

High vibration contributed to the bolts fatigue, their functional capacity was lost, and the turbine cover was opened.

- Specific direct causes—Turbine vibrations led to the fatigue damage of the mountings of Turbine #2, including the cover. Nuts on at least 6 bolts keeping the turbine cover on its place were absent. 49 bolts were investigated - 41 had fatigue cracks. On 8 bolts, the fatigue damaged areas exceeded 90% of the total crosscut area. When bolts keeping the turbine cover in place were broken, and with water pressure, the turbine with its cover, rotor, and upper parts started to move up destroying machinery. At the same time, pressurized water flooded the rooms and continued damaging plant constructions.

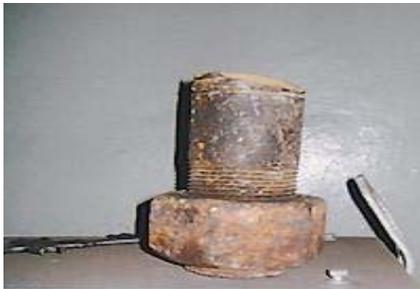
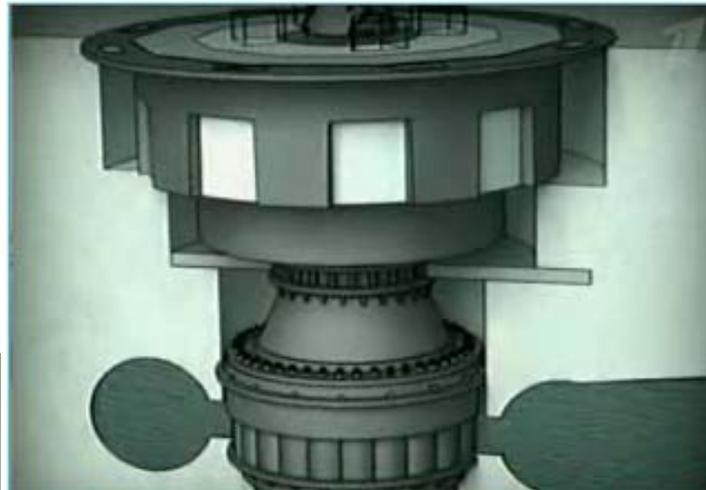
# Turbine Cover Bolts Failed on Unit 2

High pressure on a large surface had created an enormous uplifting force in the unit pit.

Water under high pressure flowed into the turbine pit.

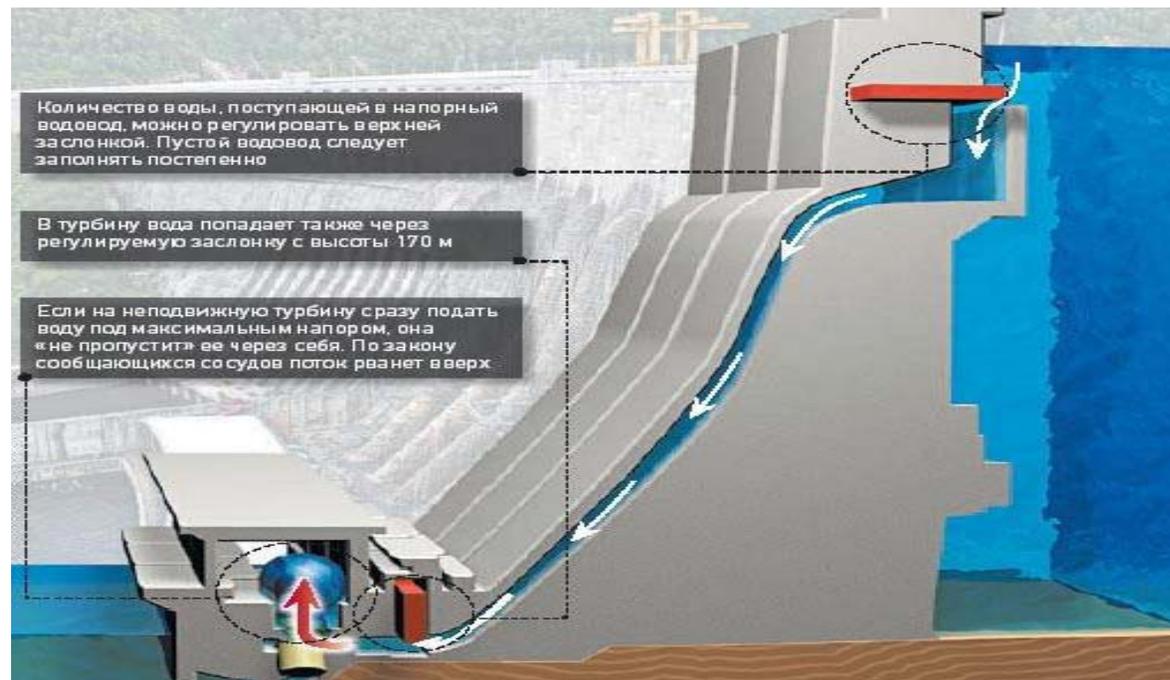
## Unit 2 Was Brutally Lifted

The unit weight is 2,691-t,  
the rotor weight is 900-t.

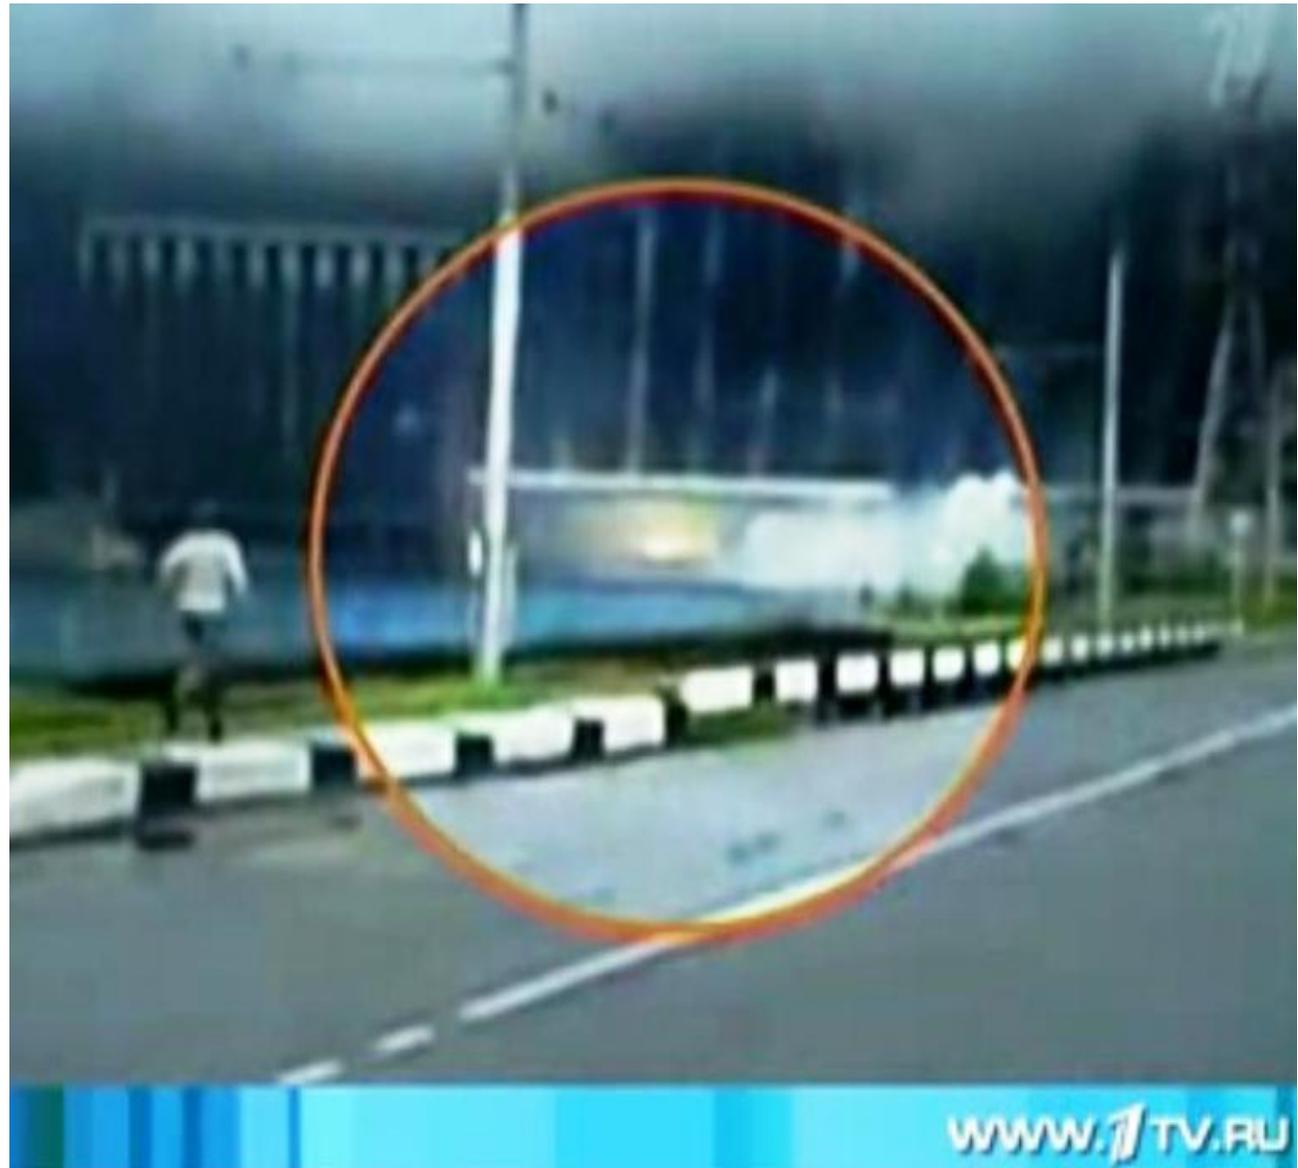
## Section of the Powerhouse Washed Away

Sudden full flooding of the powerhouse disabled the controls and protections of the units. The control systems stopped operating (no normal and no emergency electricity supply).

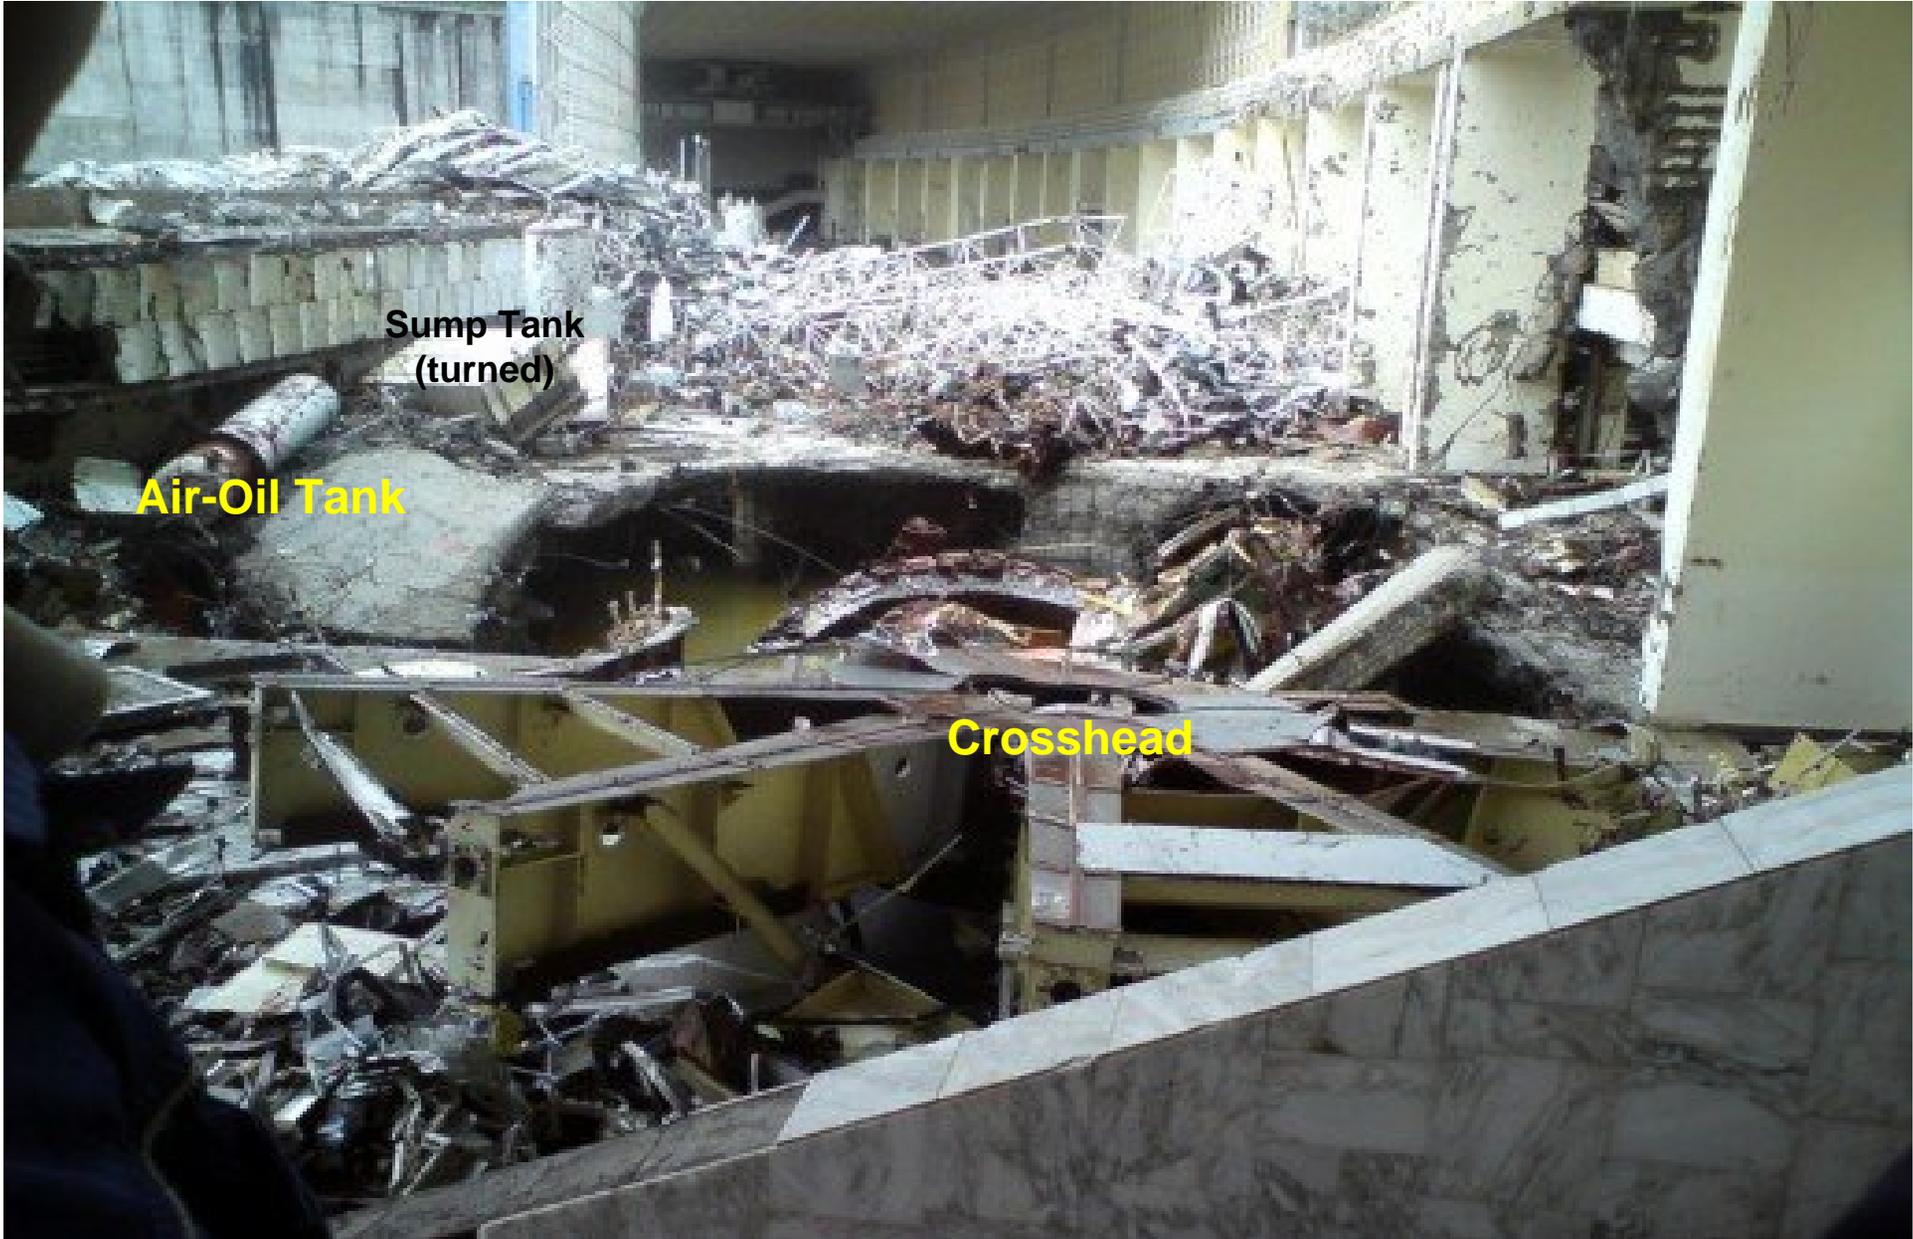
Sump Tank  
(turned)

Air-Oil Tank

Crosshead

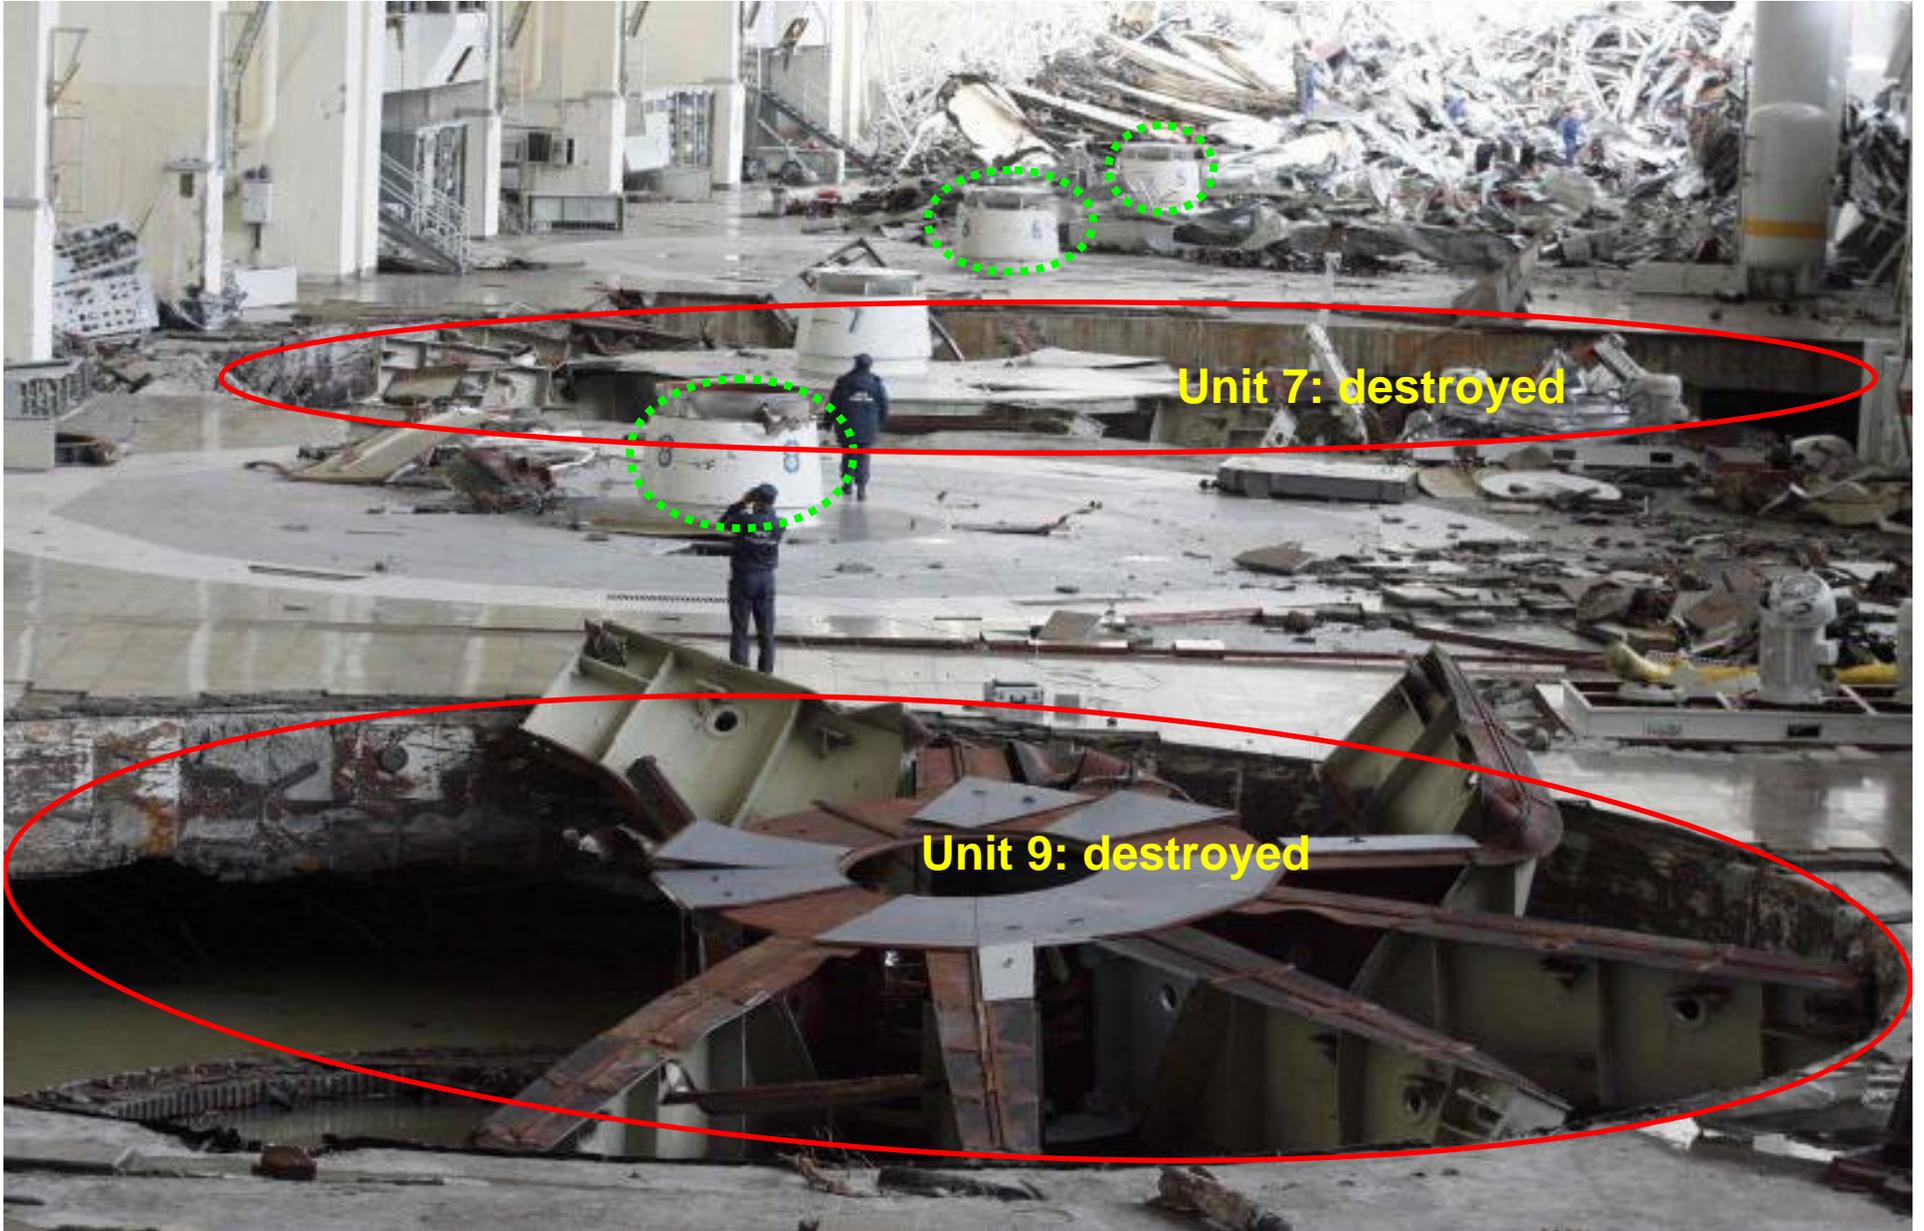
**Unit 7: destroyed**

**Unit 9: destroyed**

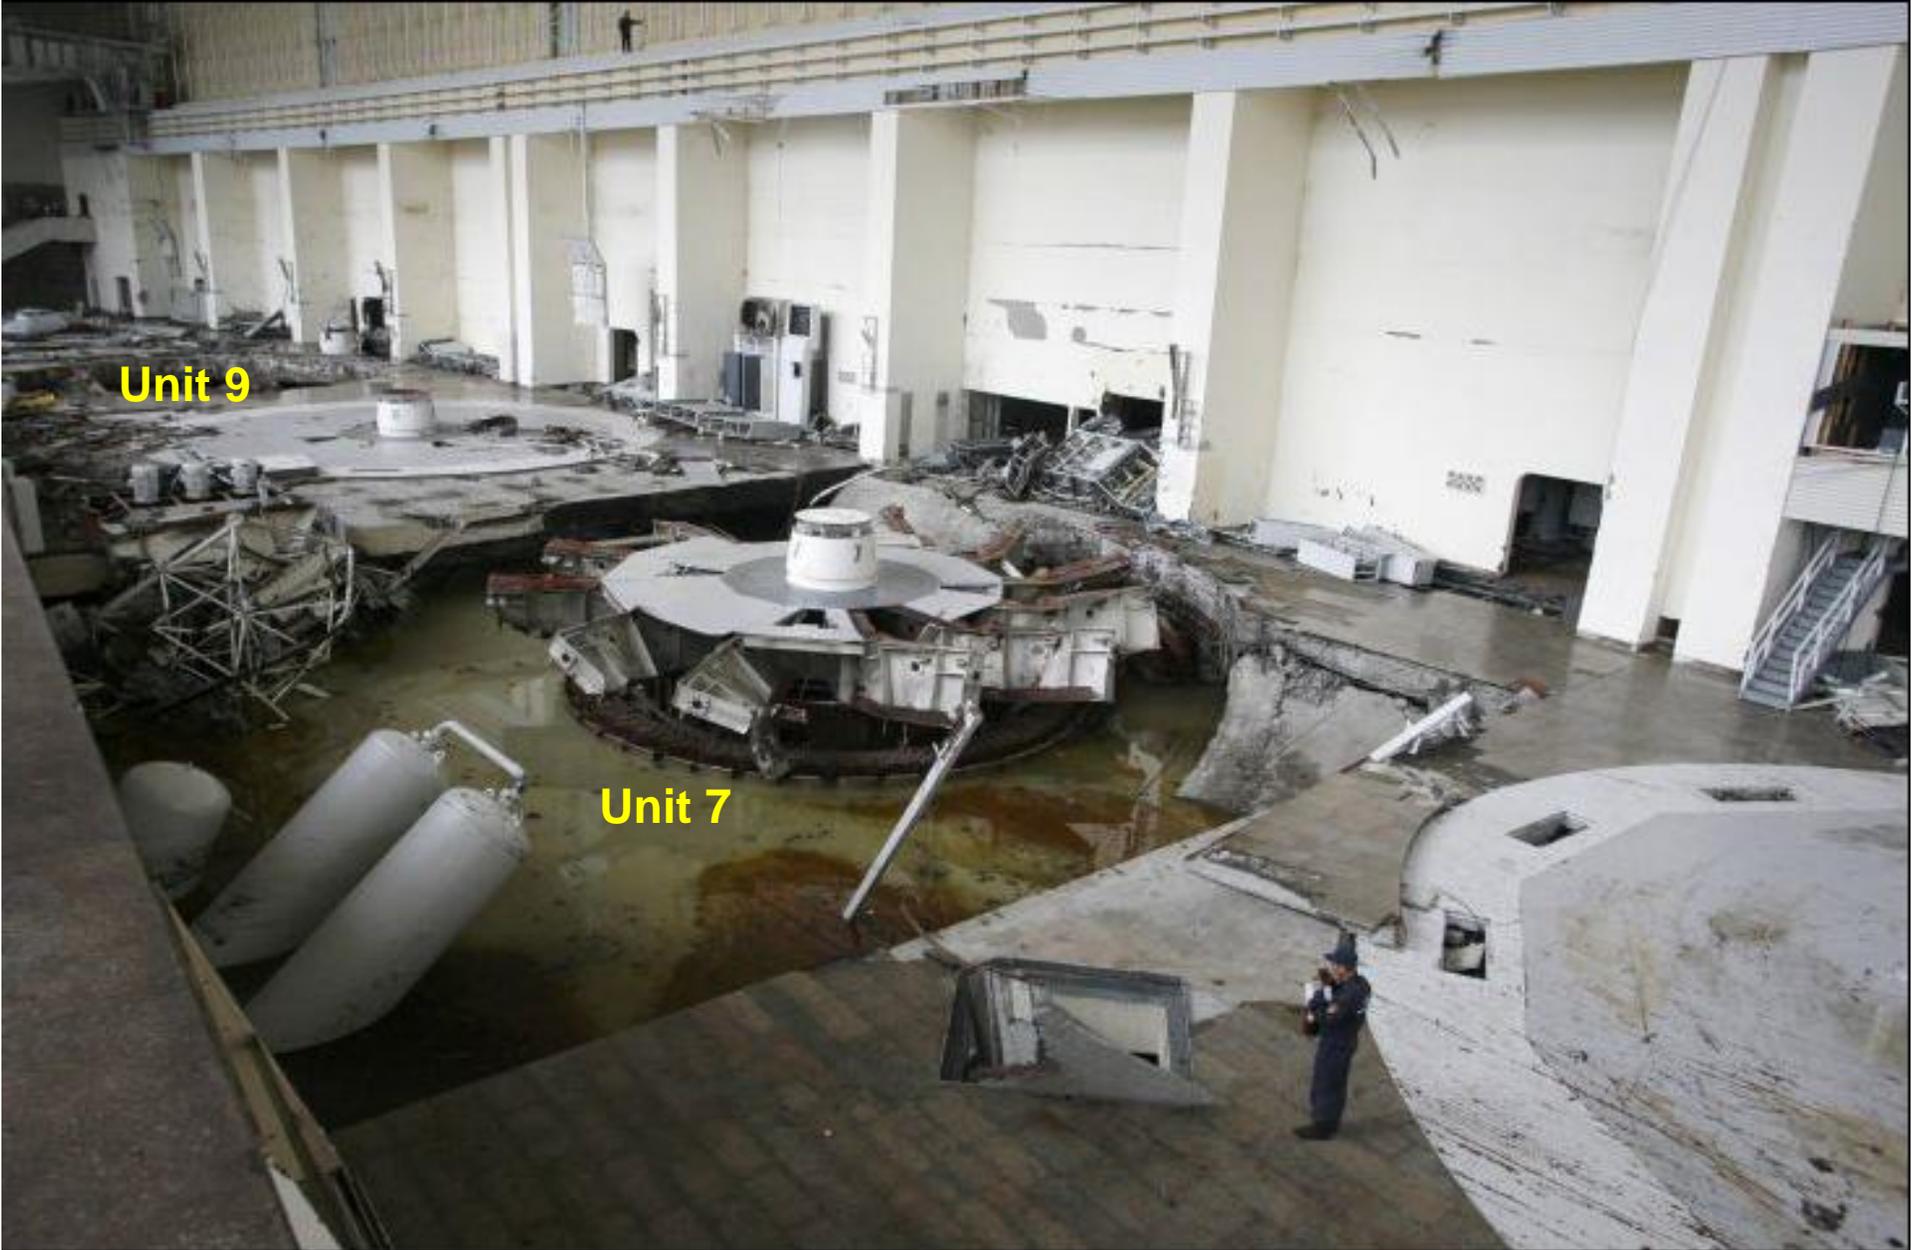
Unit 9

Unit 7

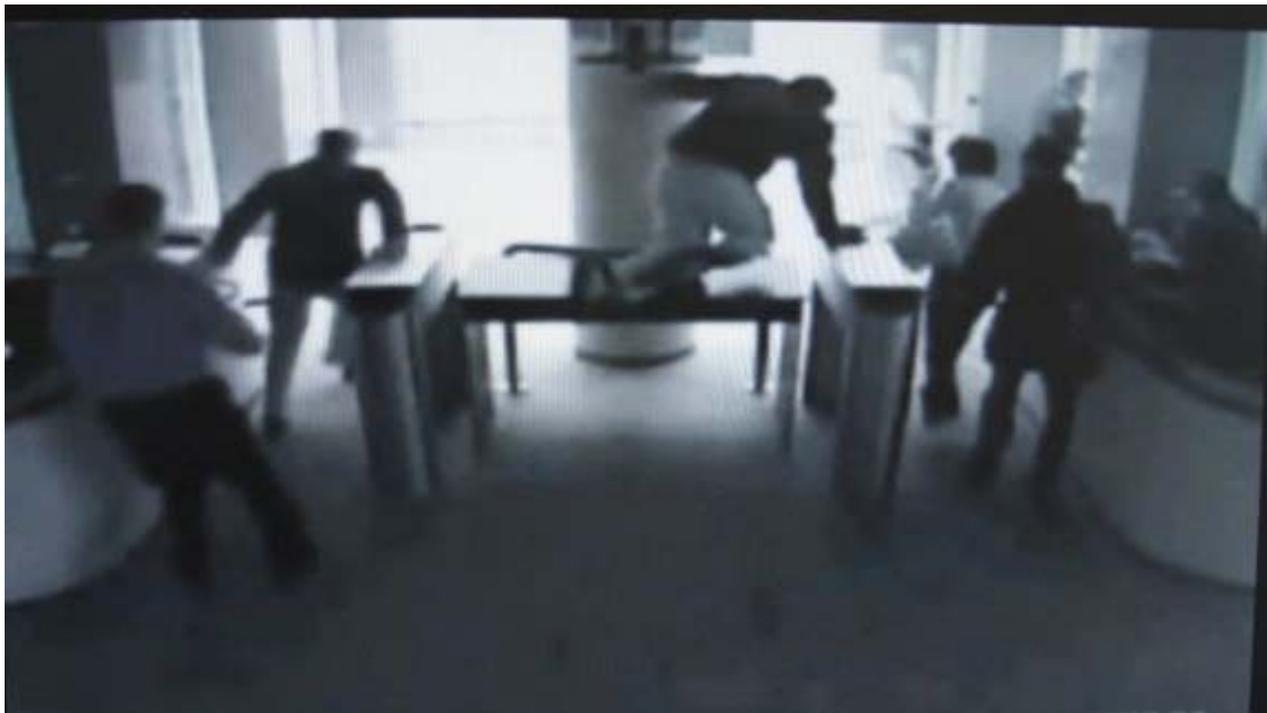
# Emergency Plan Did Not Exist

News apparently reported 3 hours after the accident

Emergency situation lasted 1hr, 7 min.  
Safety Manager abandoned the plant.

Emergency Exit signs did not exist to direct people to safe places, no drills to evaluate preparedness, only oral orders were contemplated in case of emergency.

Lack of emergency procedures

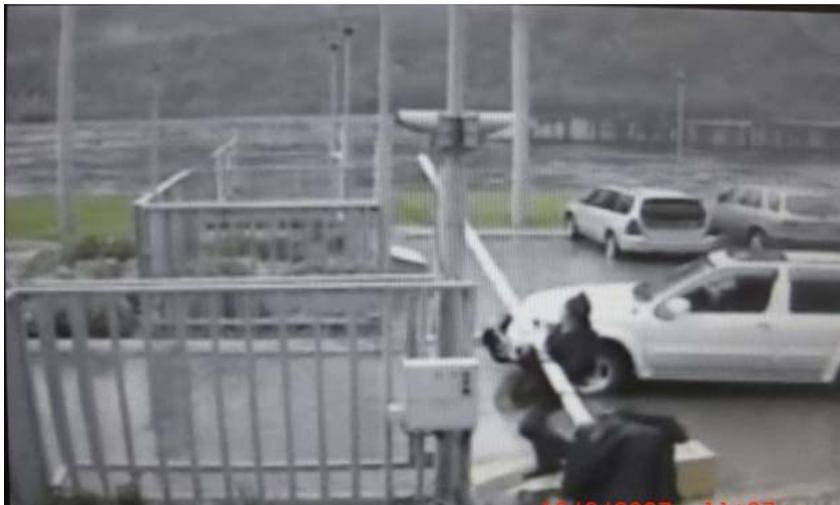
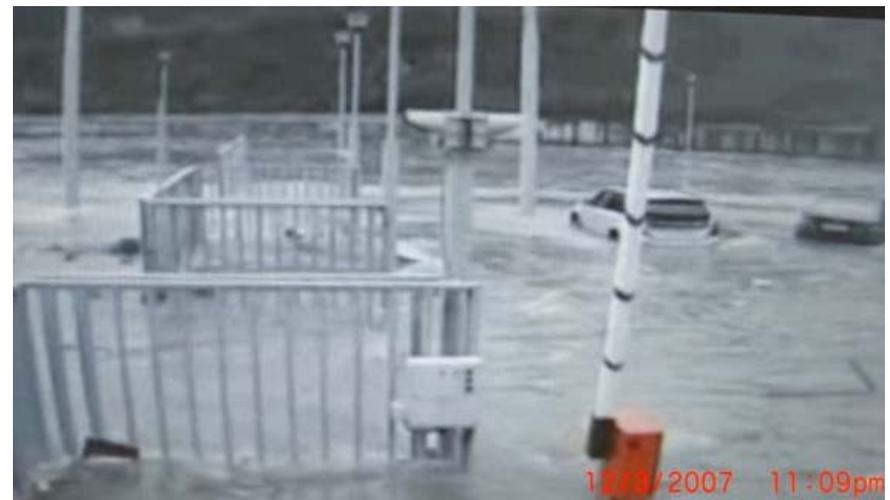
# Emergency Electricity Supply Did Not Function

- Manual attempt to open the gate
- The gate opened a few minutes later

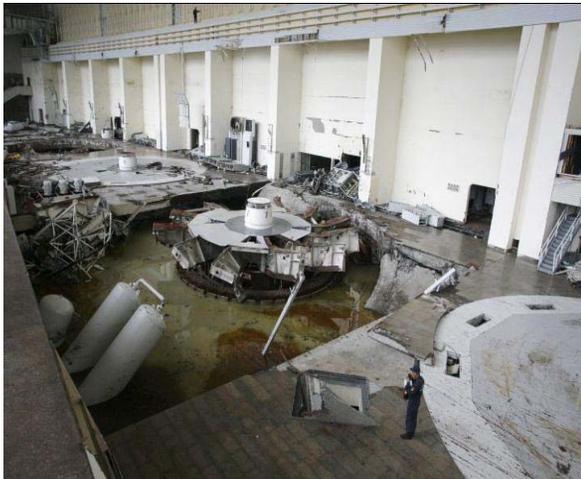
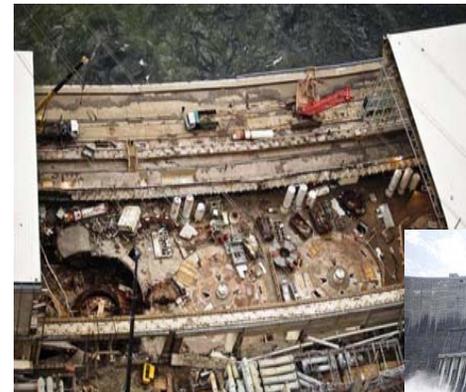
- Generators 7 & 9 were destroyed
- Short Circuit
- Air Oil Tanks Displaced
- Destroyed generator crosshead

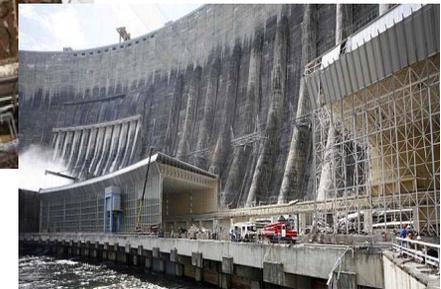
Powerhouse destroyed

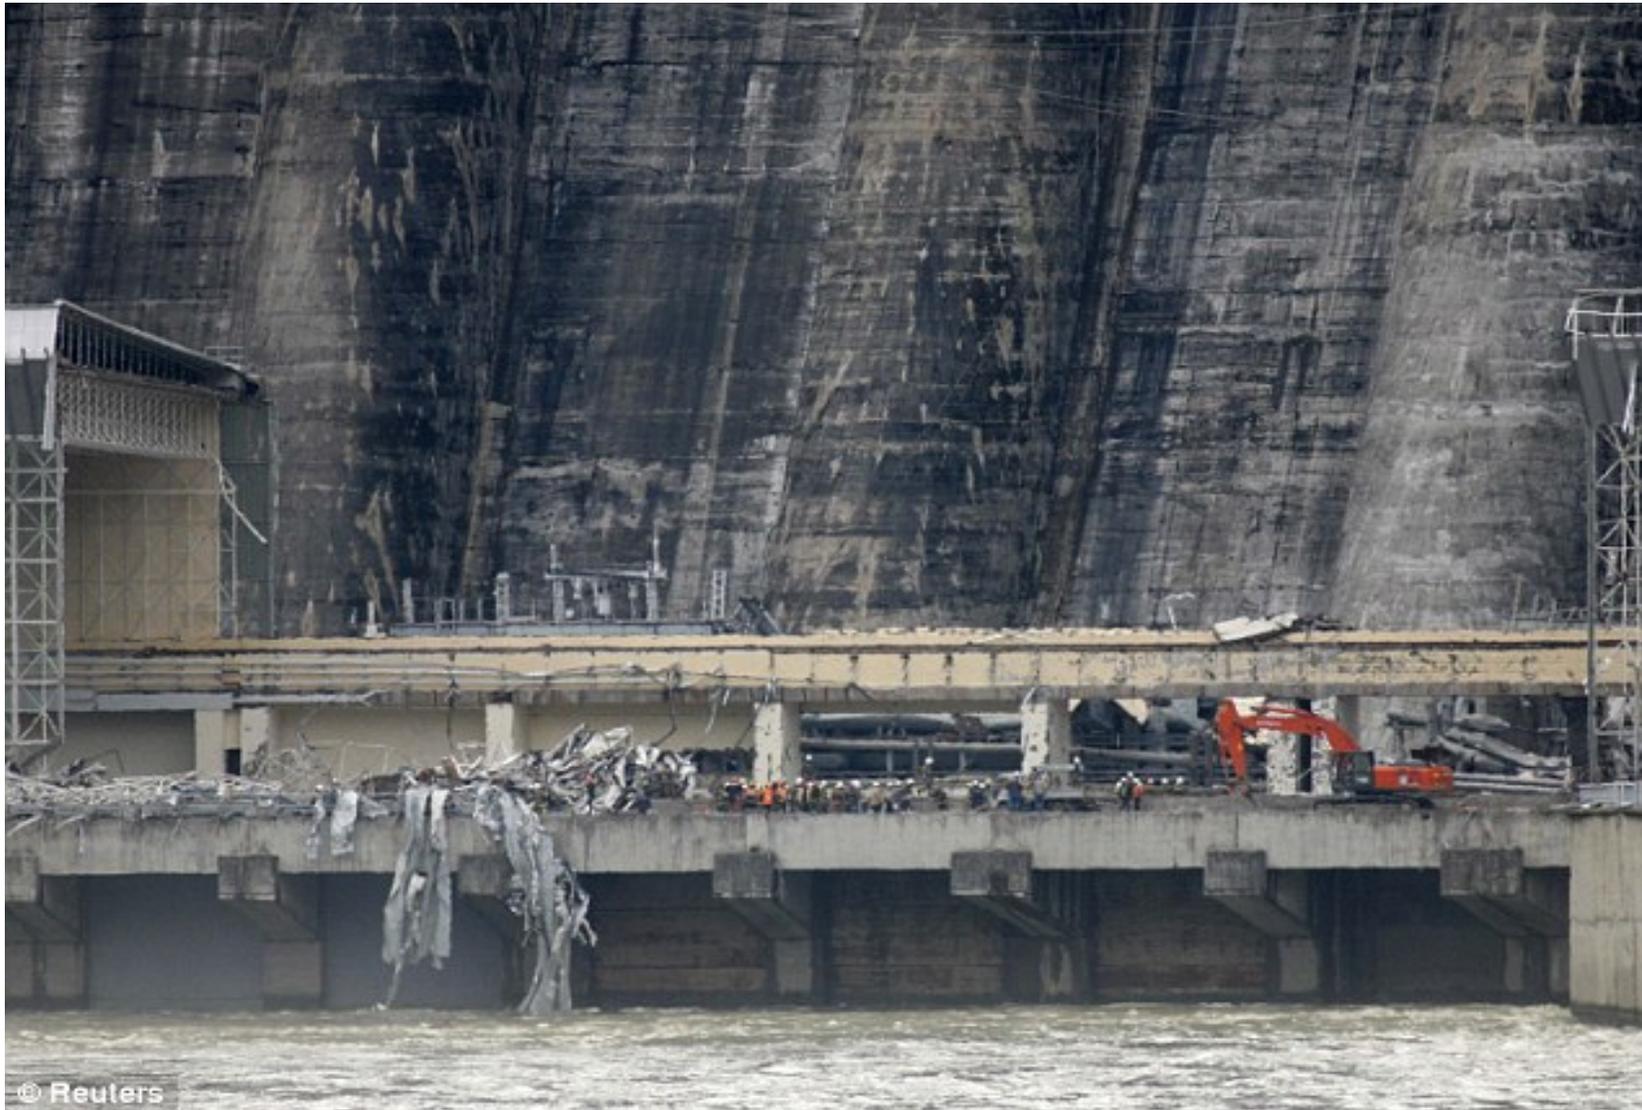
# Major Losses

Severe damage to main concrete structure of the powerhouse and partial collapse of the roof and walls.

Water under high pressure increased the initial damage.

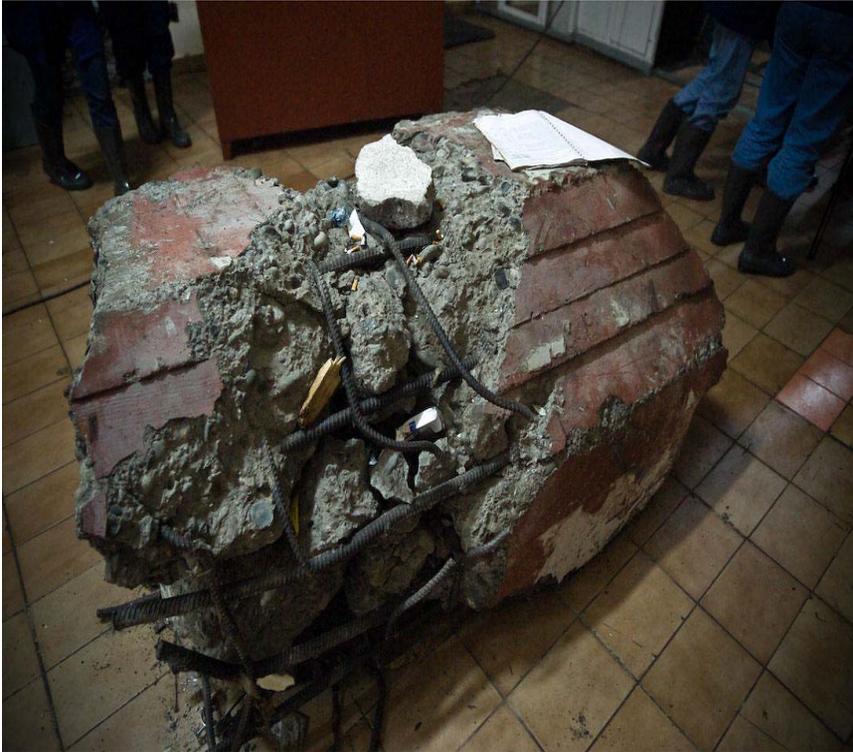
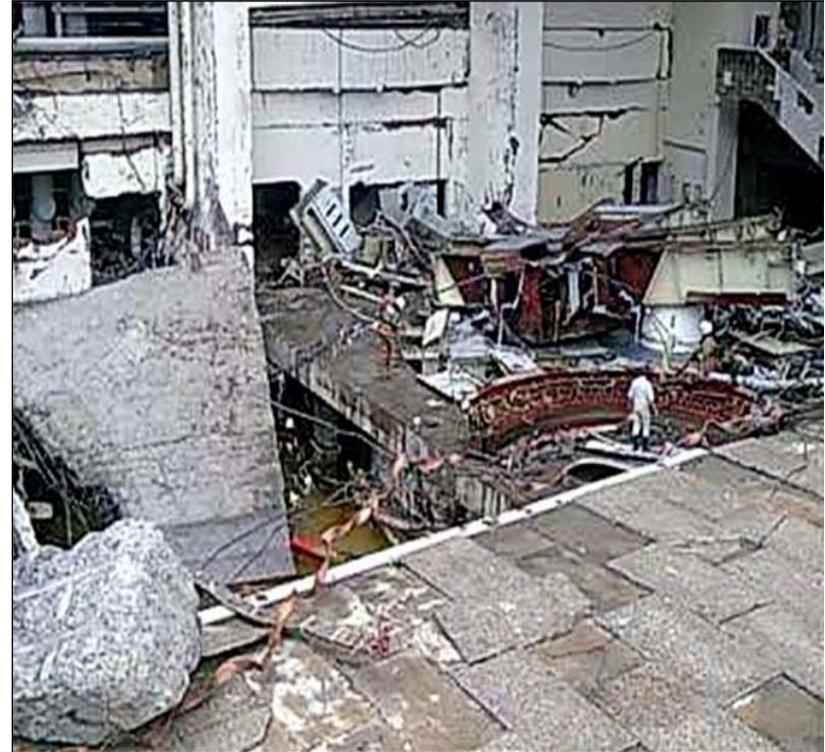
## Major Losses (continued)

Concrete elements were destroyed by brutal destruction caused by elevation of unit 2, high pressure jet streams, and collapse of the structure

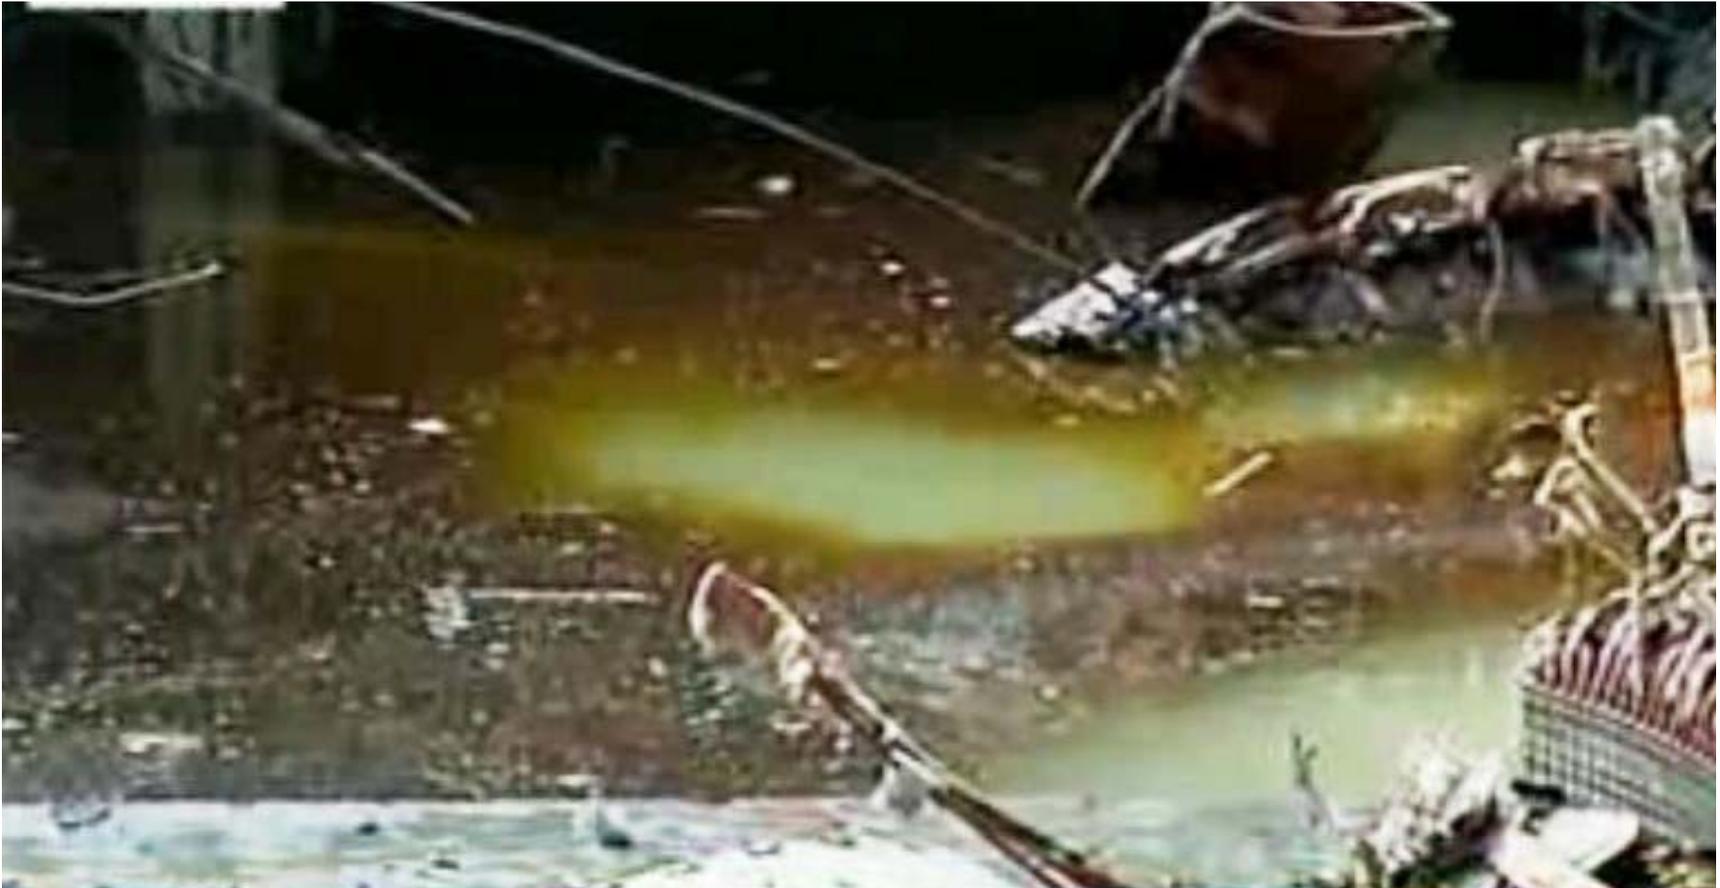
# Environmental Impact

100 t of oil had been spilled into the river. The spill flowed along the river, killing the fish and causing an environmental scandal in the news.
