# Accident at Russia's Biggest Hydroelectric Plant

Sayano-Shushenskaya – August 17, 2009

## Sayano-Shushenskaya hydro-electric power plant

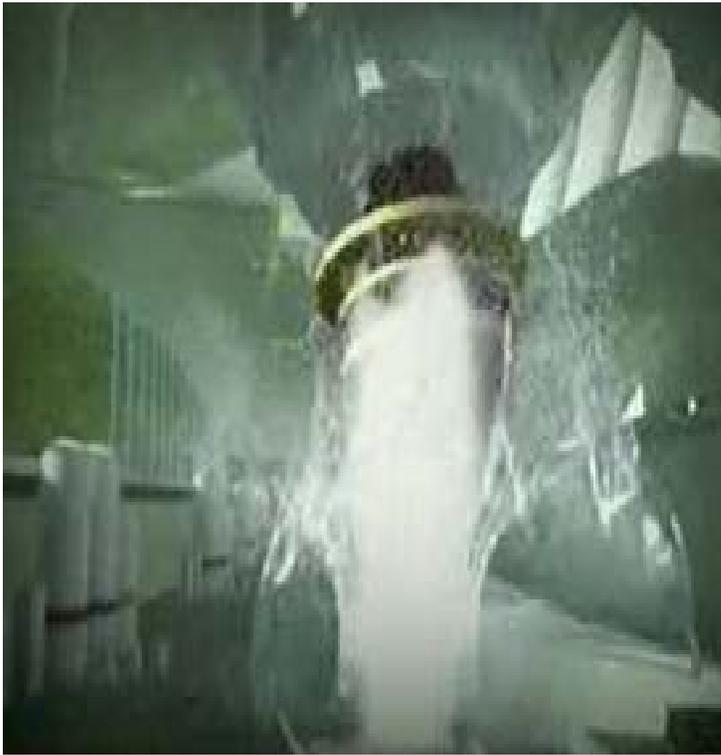
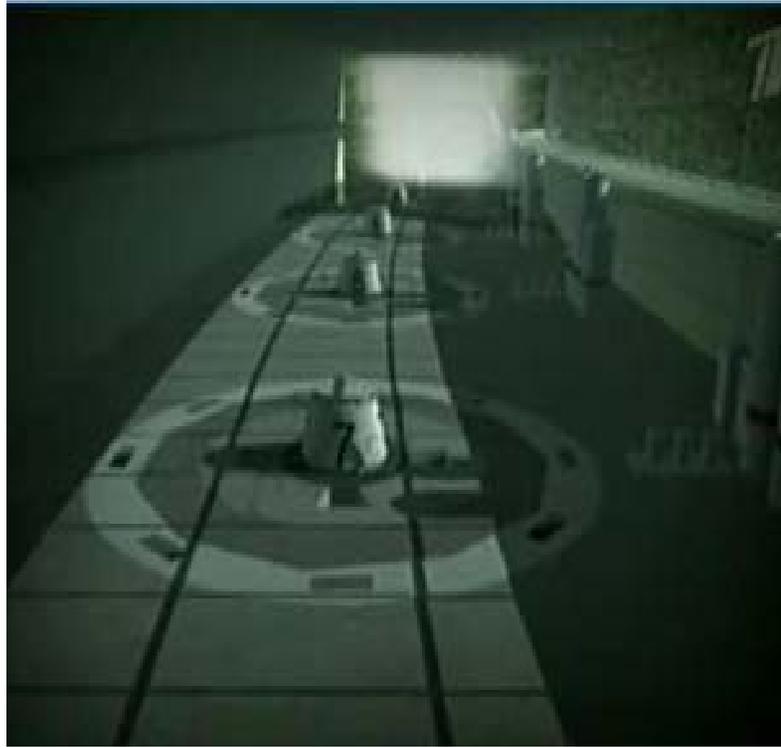
# Flooding of the Powerhouse Started

Sudden full flooding of the powerhouse disabled the controls and protections of the units. The control systems stopped operating (no normal and no emergency electricity supply).

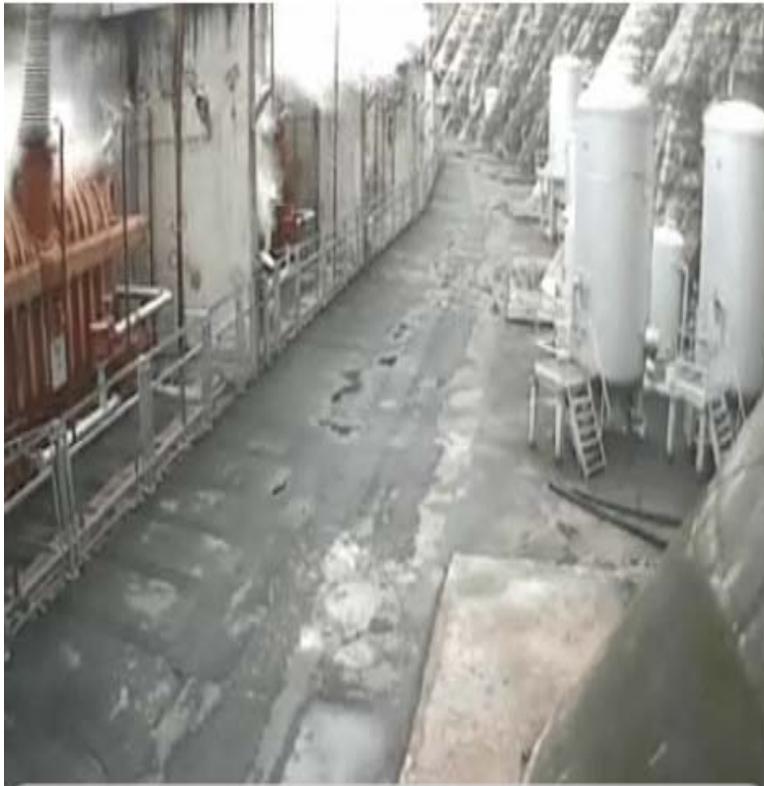
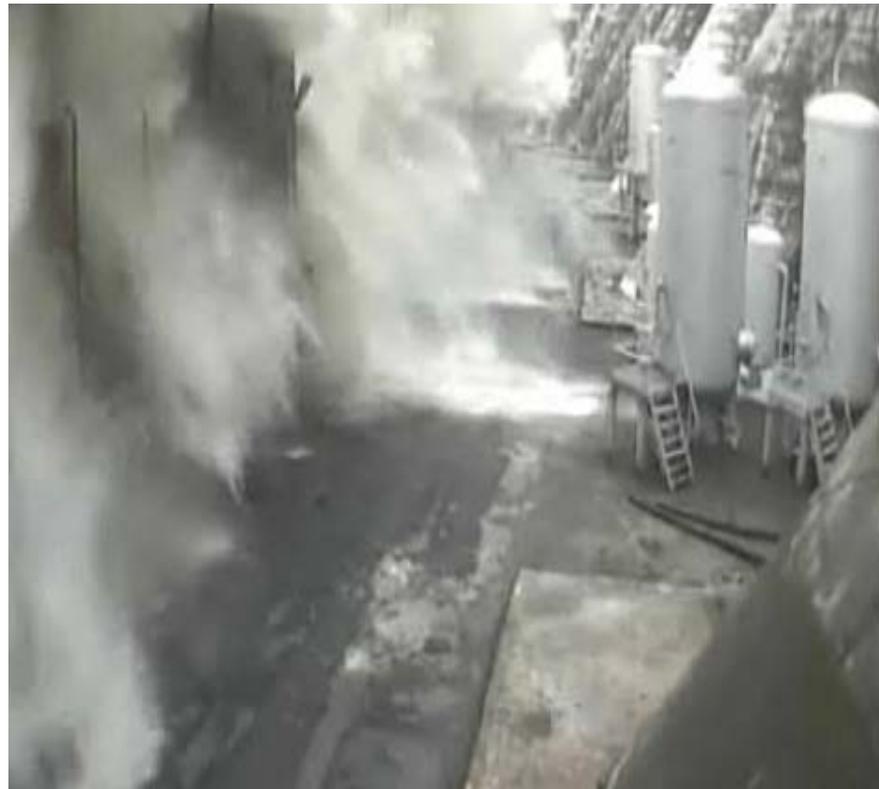
# Flooding of Transformers

- Water immediately flooded the engine and turbine rooms and caused a transformer explosion.
- **On 23 August 2009**, authorities said 69 people were found dead while 6 people are still listed as missing. Efforts to pump flood water from the engine room and complete a search for the missing workmen are expected to take 3 to 8 days.

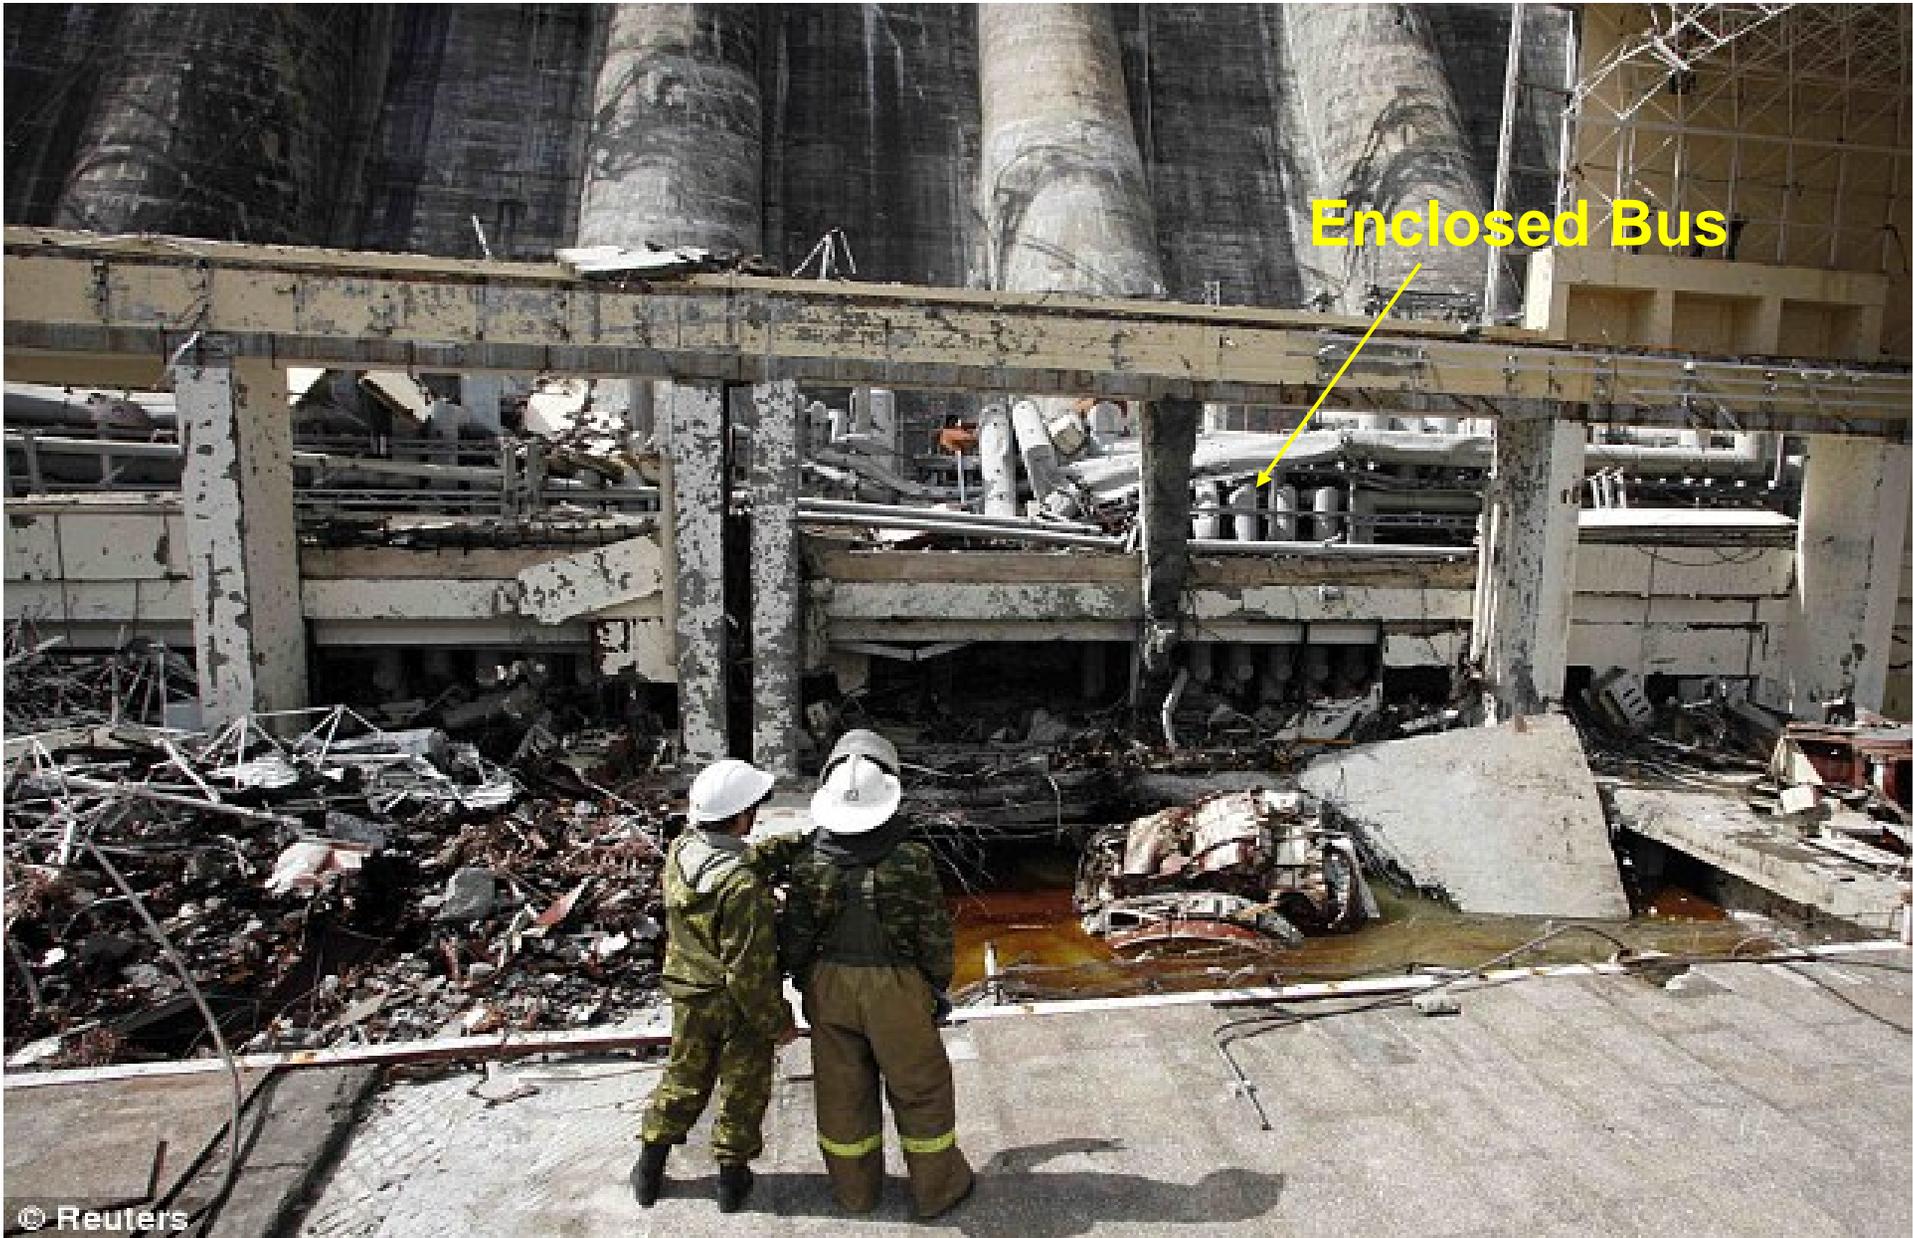
Enclosed Bus
