Office of Health, Safety and Security

Monthly Analysis of Electrical Safety Occurrences

June 2011

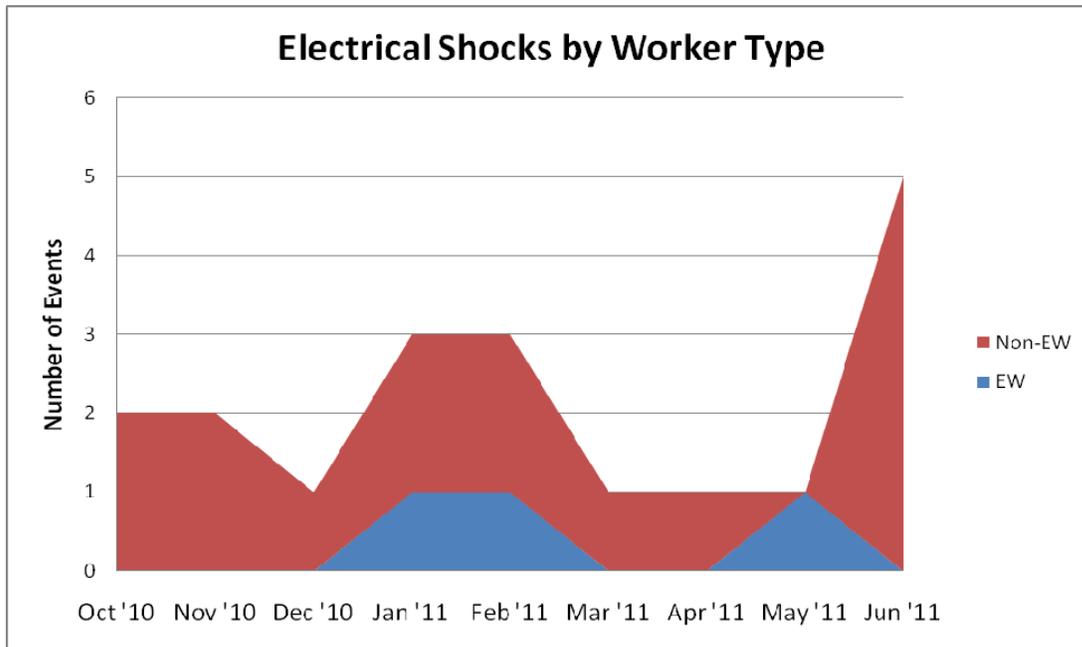
The following chart shows that non-electrical workers have experienced the majority of the electrical shocks. Since the beginning of FY 2011, 84 percent of the occurrences that resulted in contact with electrical energy involved non-electrical workers. It is expected that electrical workers would have a low incidence of electrical shock because of their knowledge, skills and abilities. Electrical safety awareness training is important for non-electrical workers, but we also need to eliminate hazards that might not be obvious to the non-electrical worker. These hazards can be in the form of poorly maintained equipment (e.g., not properly bonded or grounded), faulty switches, outlets and electrical connections, or energized circuits that are abandoned in place.

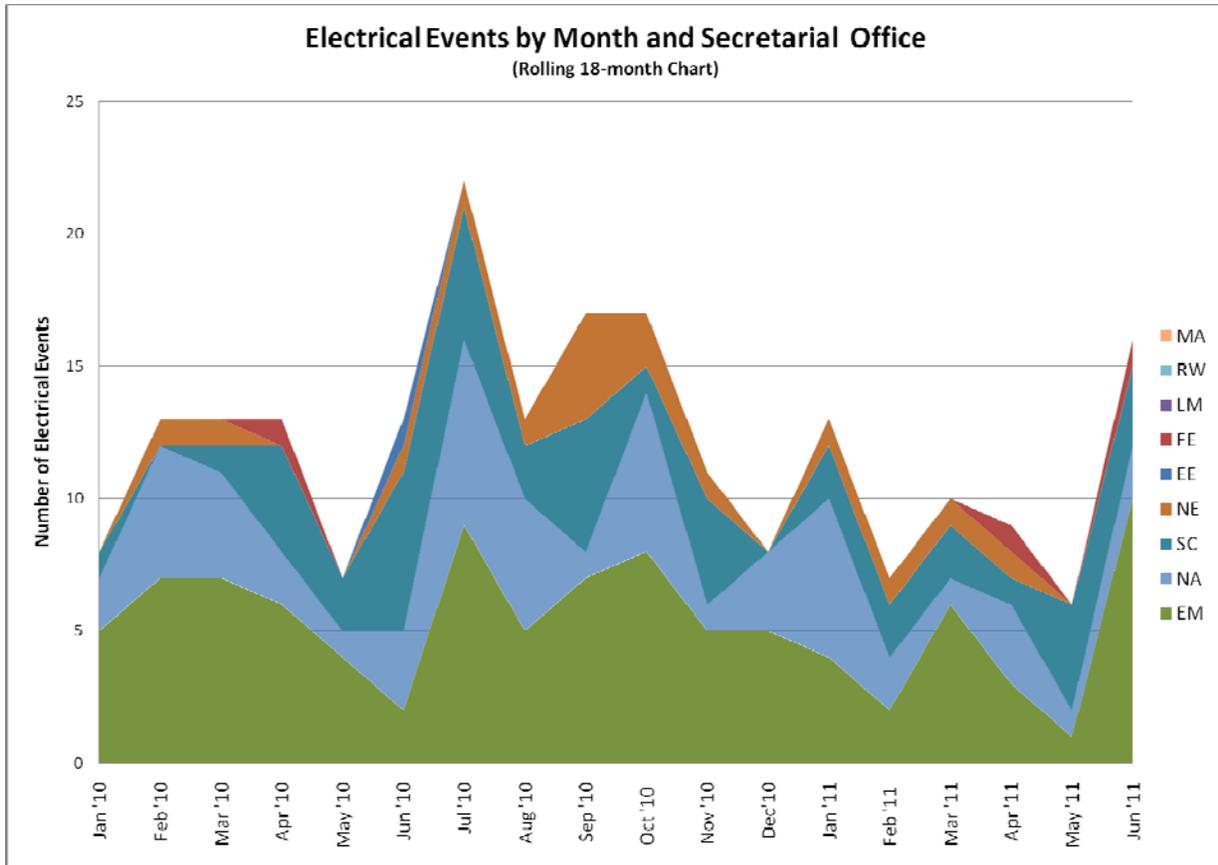
The following chart shows the distribution of electrical safety occurrences by secretarial office. As can be seen, the biggest contributor for June was from activities reported at Environmental Management sites.

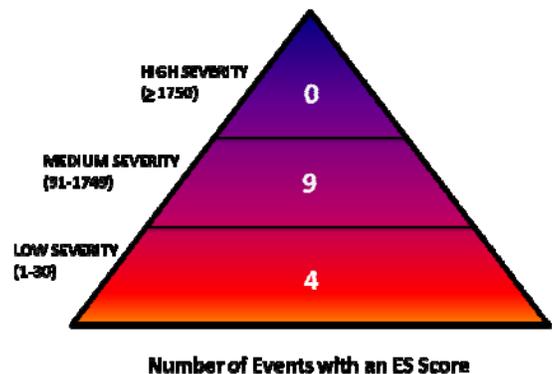
The electrical severity scores are calculated using Revision 2 of the Electrical Severity Measurement Tool, which can be found on the EFCOG website at http://www.efcog.org/wg/esh_es/docs/Electrical_Severity_Measurement_Tool.pdf. Three of the electrical occurrences this month did not have an Electrical Severity (ES) score. The other 13 events are distributed as shown in the triangle, with the highest ES score being 1050. The actual score for each event is provided in the event tables (Attachment 1).

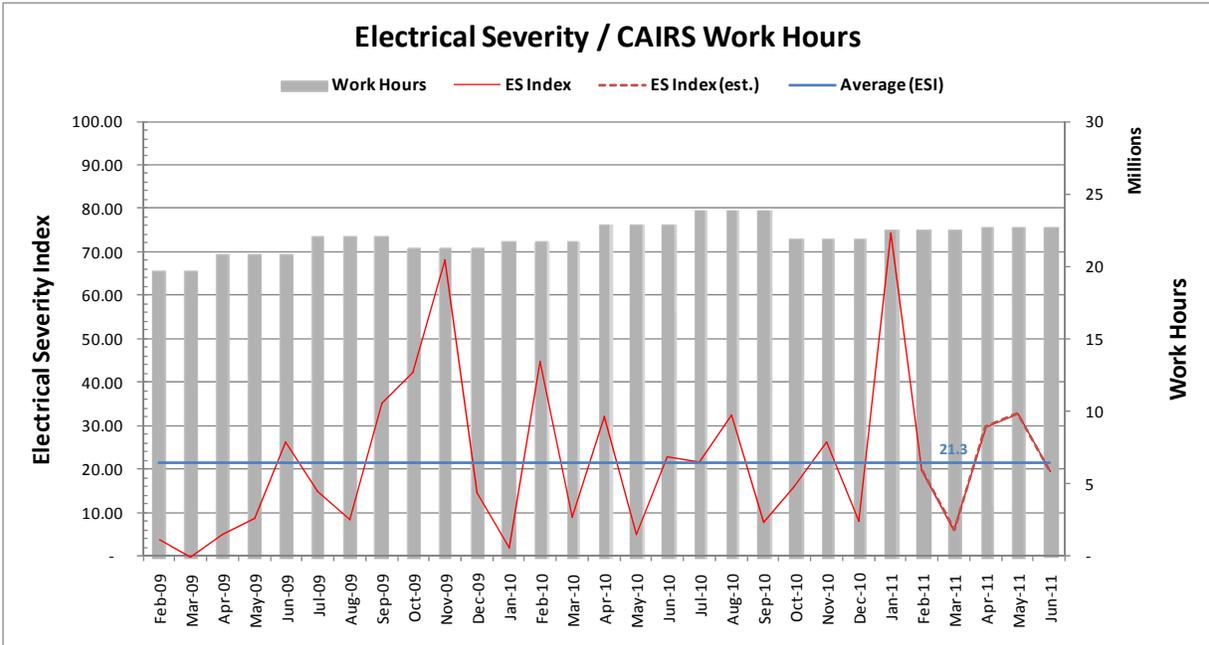
The Electrical Severity Index (ESI) is a performance metric that was developed to normalize events against organizational work hours. The ESI is calculated monthly and trended. Each DOE site calculates their own ESI and sets their own annual ESI goals. These ESI goals can vary from 0.22 to 160.0. Presently, the DOE complex goal is for the monthly ESI to be below the average ESI and to reduce the average ESI for the DOE complex to < 20.0. This average ESI goal was established based on the average ESI for 2009 (18.99) and 2010 (19.03). The following chart shows a calculated ESI for the DOE complex.

Note: An estimated ESI is calculated until accurate CAIRS man-hours are available. The chart is updated monthly.

Category	May	June	Δ
Total Occurrences	6	16	+10
Total Electrical Severity	3,700	2211	-1489
Estimated Work Hours	22,629,634* (22,301,737)	22,631,855	+2,221
ES Index	32.70* (33.18)	19.54	-13.16
Average ESI	21.4	21.3	-0.1

$$\text{Electrical Severity Index} = (\Sigma \text{Electrical Severity} / \Sigma \text{Work Hours}) 200,000$$

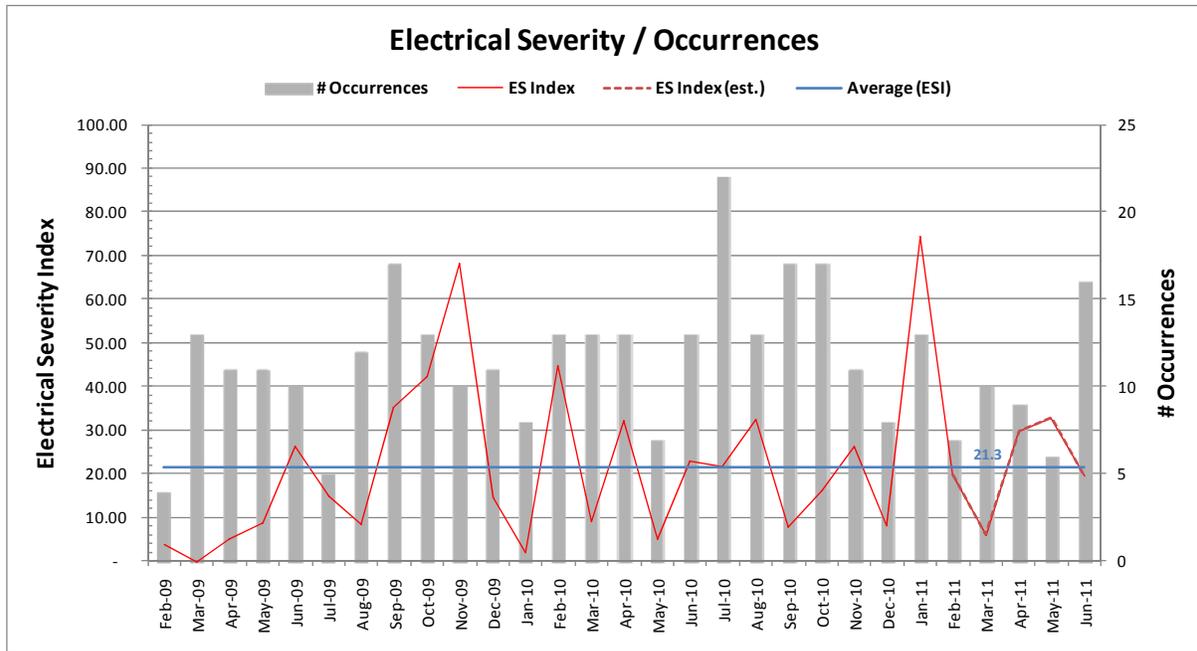
The following chart shows ESI with the number of Occurrences instead of work hours.

The average ESI has increased from 19.2 in June 2010 to 21.3 in June 2011. The ongoing efforts of the EFCOG Electrical Safety Subgroup and the recommendations from the various subcommittees (e.g., Hazardous Energy Control, Subsurface Investigation, etc.) can help reduce the number of medium and high electrical severity events and thus reduce the ESI.

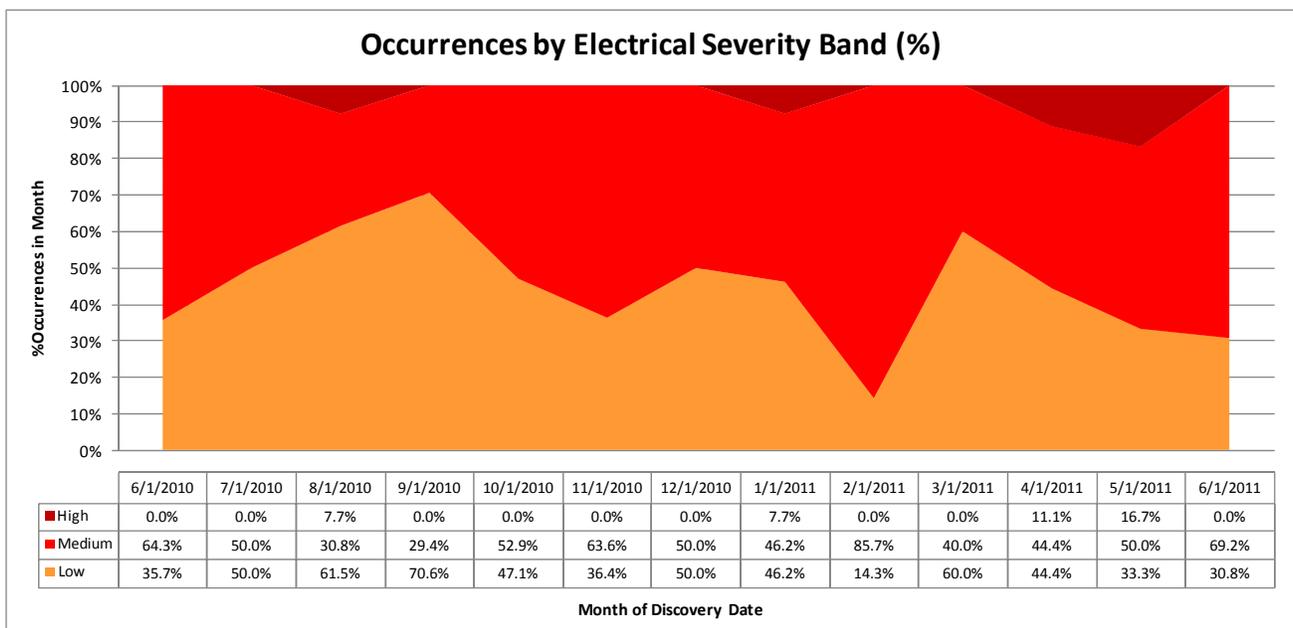
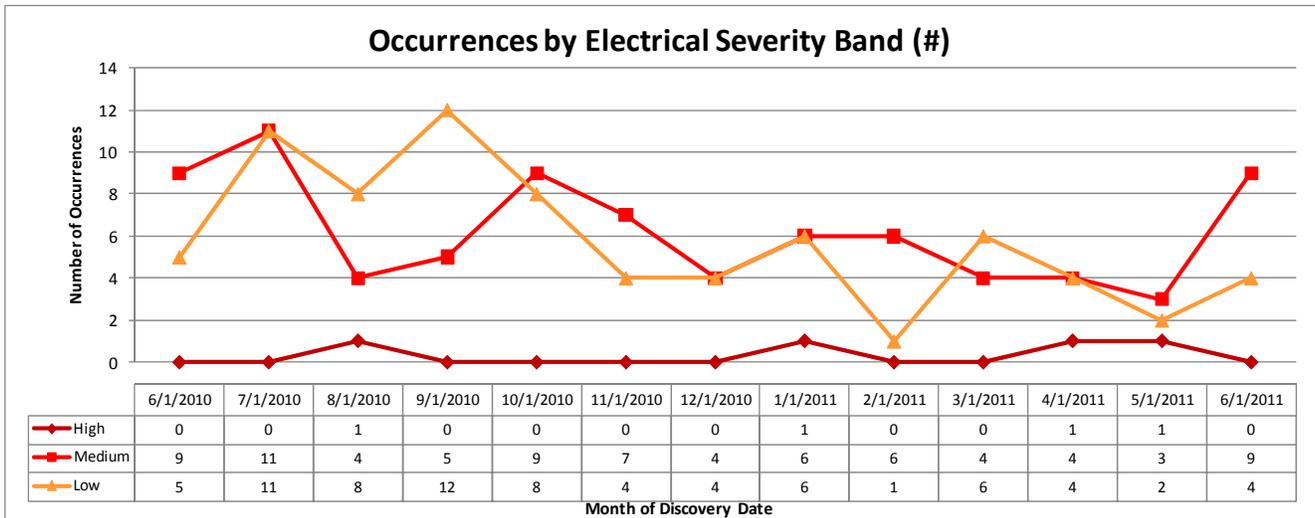
For the interval June 2010 through June 2011 (current month and the past 12), the next two charts summarize occurrences by severity band and month of discovery date:

- By percentage of total occurrences in month
- By number of occurrences in month

What we can see from the previous two charts is that the number of occurrences with High electrical severity scores decreased to zero for the June and that the number of occurrences with Low electrical severity scores and Medium scores both increased. There were more Medium severity occurrences than Low severity occurrences. Ideally, we want to see more Low than Medium severity occurrences as in September 2010 and March 2011.

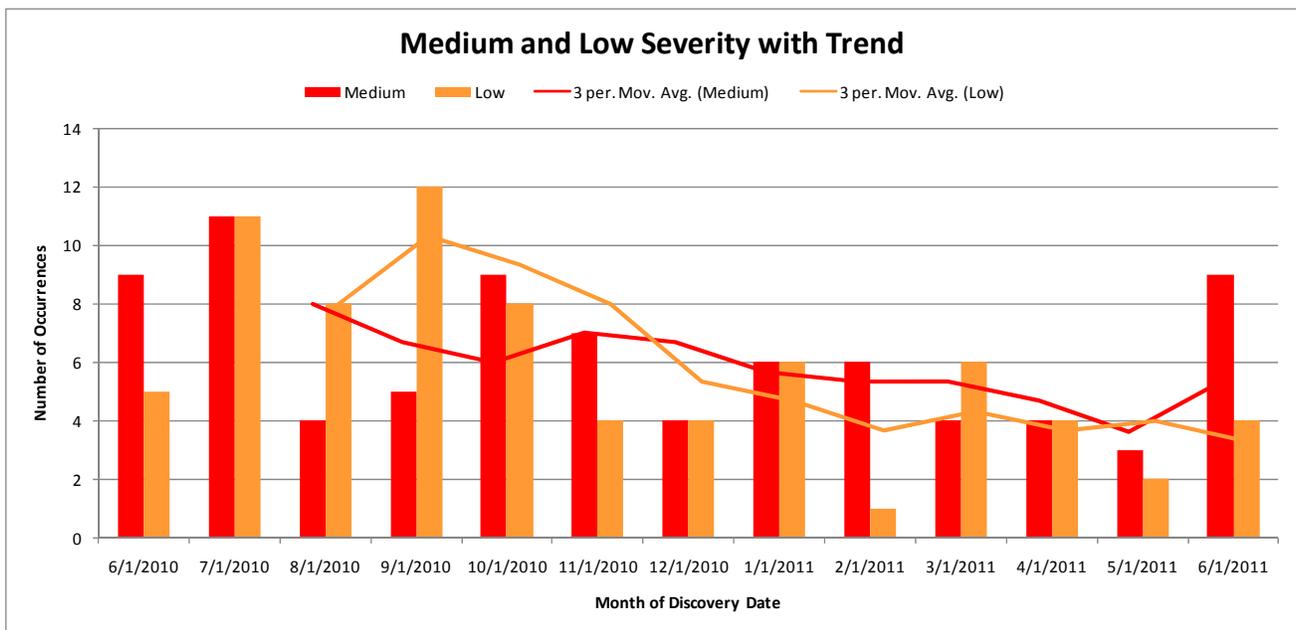
The following chart focuses on the Medium and Low severity data series for June 2010 through June 2011. Trend lines are included for each, using a 3-month moving average.

The 3-month moving average shows continued improvement in Low severity events and slight increase in Medium severity occurrences.
