Office of Health, Safety and Security

Monthly Analysis of Electrical Safety Occurrences

October 2011

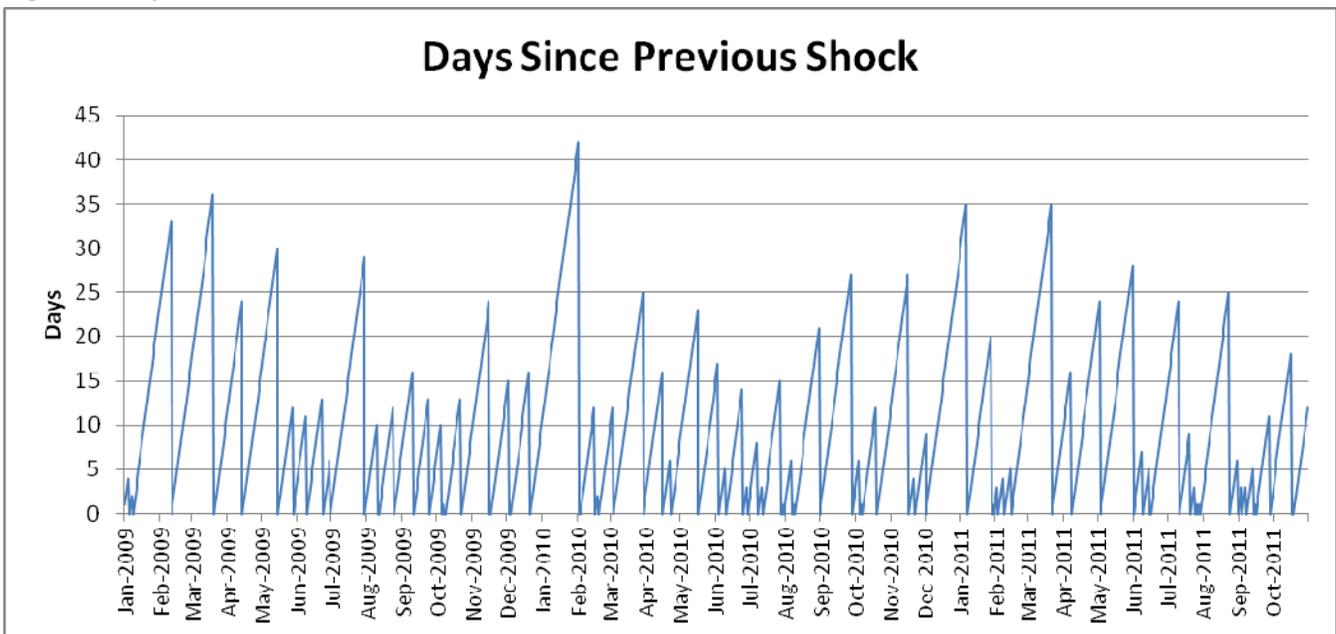
Figure 1 shows the number of days since the previous electrical shock for the DOE complex. The present interval is 12 days. The longest interval was 41 days in 2010.

Figure 1 - Days since Previous Shock

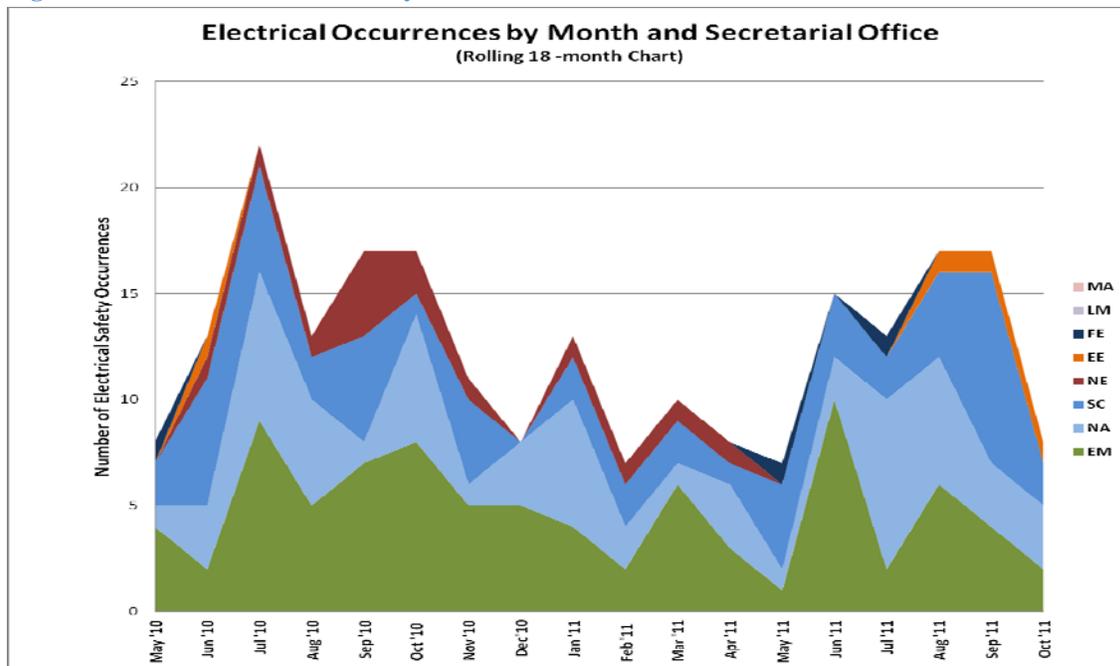
Figure 2 shows the distribution of electrical safety occurrences by secretarial office. The Office of Nuclear Energy and the Office of Fossil Energy have not reported an occurrence in several months.

Figure 2 - Electrical Occurrences by Month and Secretarial Office

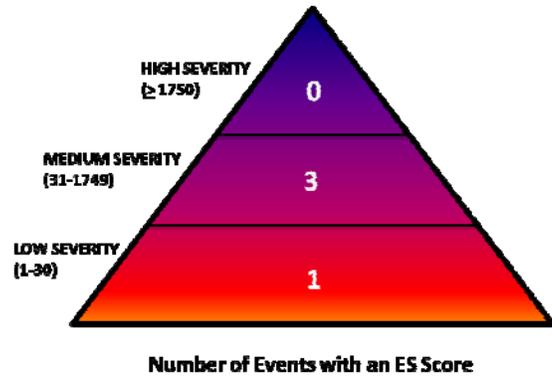
The electrical severity scores are calculated using Revision 2 of the Electrical Severity Measurement Tool, which can be found on the EFCOG website at http://www.efcog.org/wg/esh_es/docs/Electrical_Severity_Measurement_Tool.pdf. Four of the electrical occurrences this month did not have an Electrical Severity (ES) score. The other four occurrences are distributed as shown in Figure 3, with the highest ES score being 330. The actual score for each occurrence is provided in Attachment 1.

Figure 3 - Electrical Severity Count

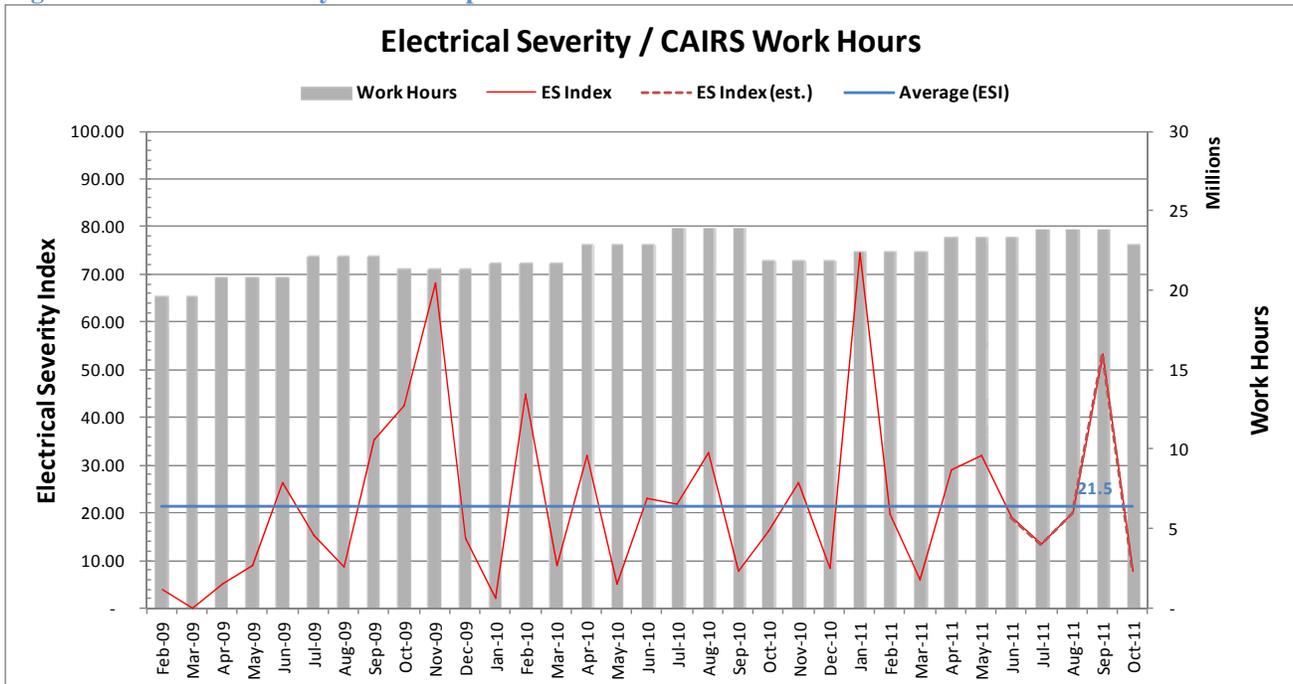
The Electrical Severity Index (ESI) is a performance metric that was developed to normalize events against organizational work hours. The ESI is calculated monthly and trended. Each DOE site calculates their own ESI and sets their own annual ESI goals. Figure 4 shows a calculated ESI for the DOE complex and Table 3 shows the ESI and how it has changed from the previous month.

Figure 4 - Electrical Severity Index Compared to Work Hours

Note: An estimated ESI is calculated until accurate CAIRS man-hours are available. The chart is updated monthly.

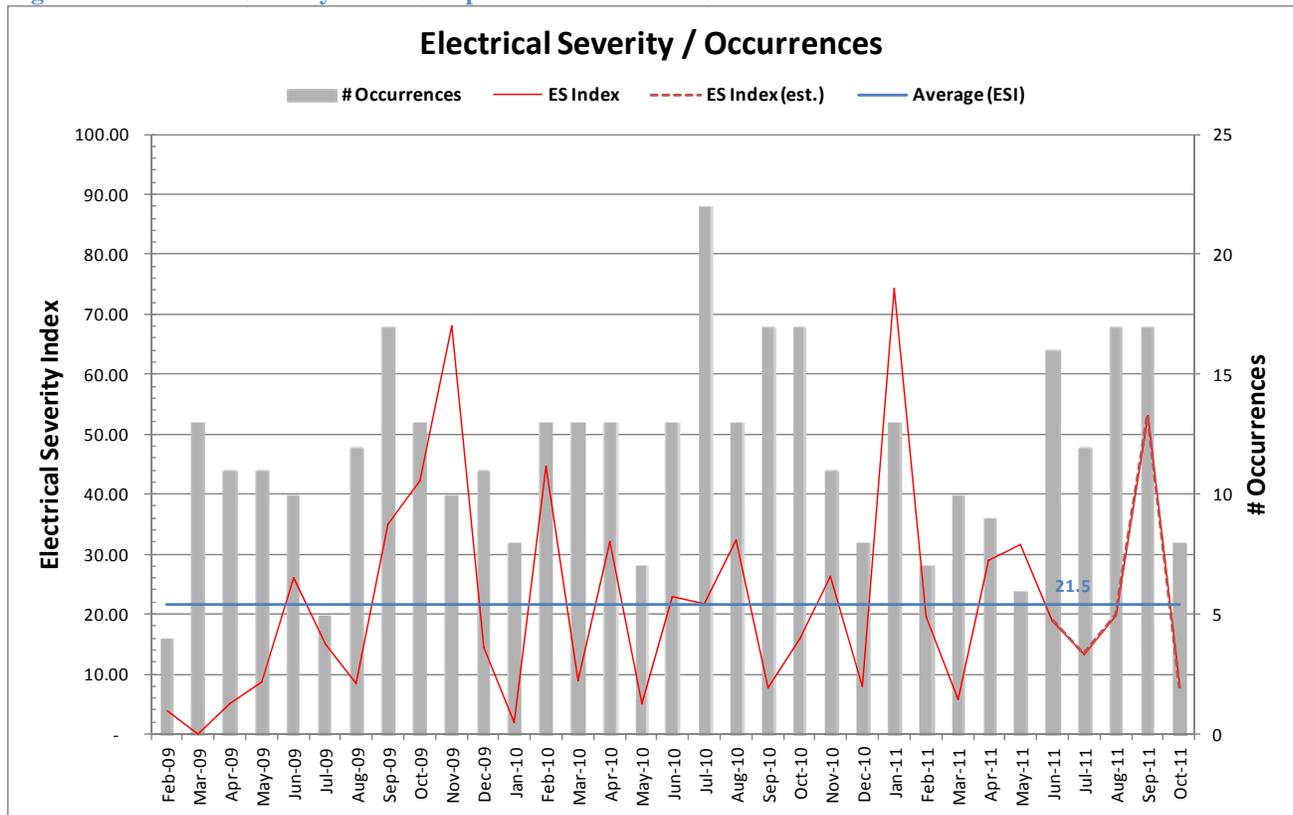
Figure 5 shows the ESI with the number of Occurrences instead of Work Hours.

Figure 5 - Electrical Severity Index Compared to Number of Occurrences

The average ESI has increased from 19.2 in June 2010 to 21.5 in October 2011.

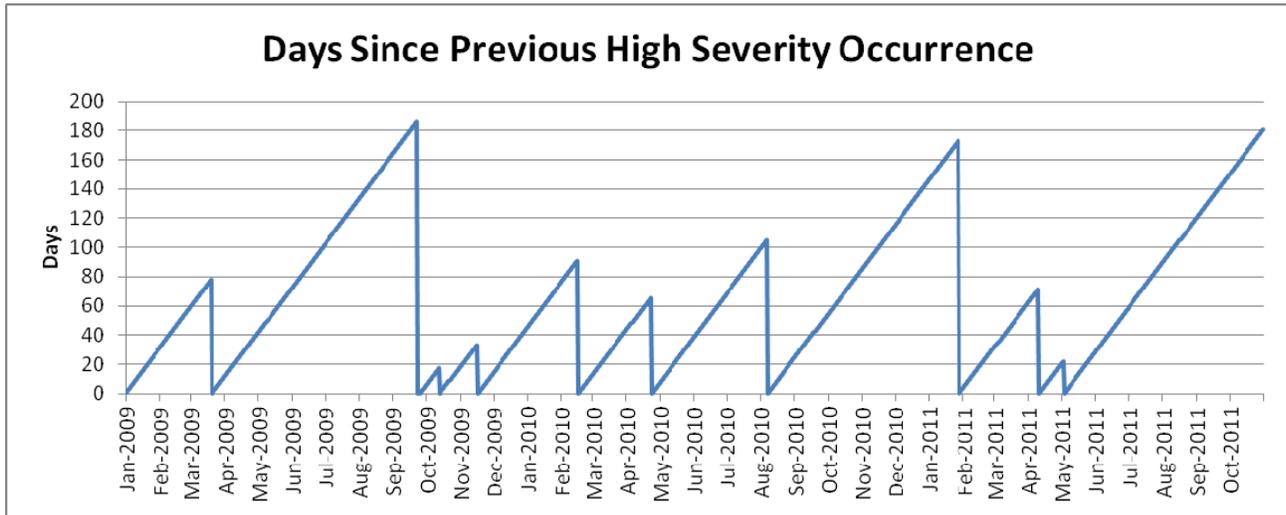
The following chart shows the number of days since the previous high severity occurrence. The present interval is 180 days and is approaching the longest interval of 181 days in 2009.

Figure 6 - Days since Previous High Severity Occurrence

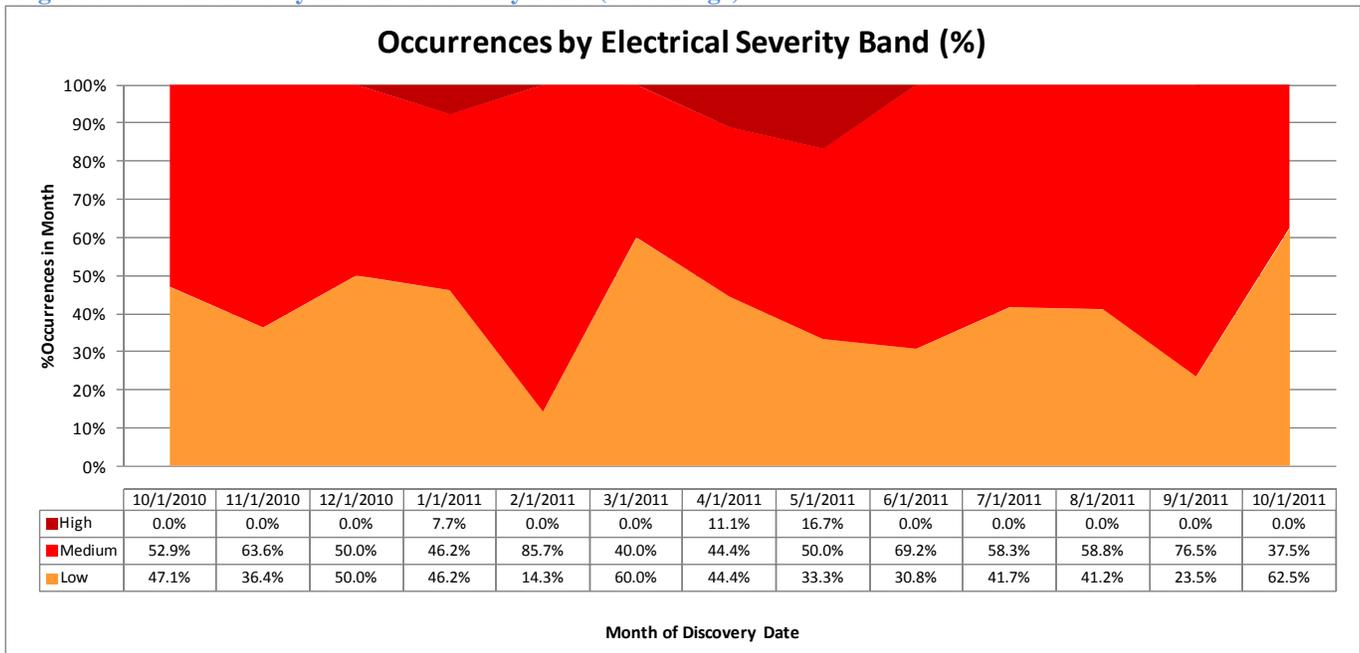
For the interval October 2010 through October 2011 (current month and the past 12), Figures 7 and 8 summarize occurrences by severity band and month of discovery date by percentage of total occurrences in month and number of occurrences in month.

Figure 7 - Occurrences by Electrical Severity Band (Percentage)

What can be seen from the previous two charts is that the number of occurrences with High electrical severity scores has remained at zero for the past five months and that the number of occurrences with Medium scores, following a steady increase since May, have dropped below the number of Low severity occurrences.

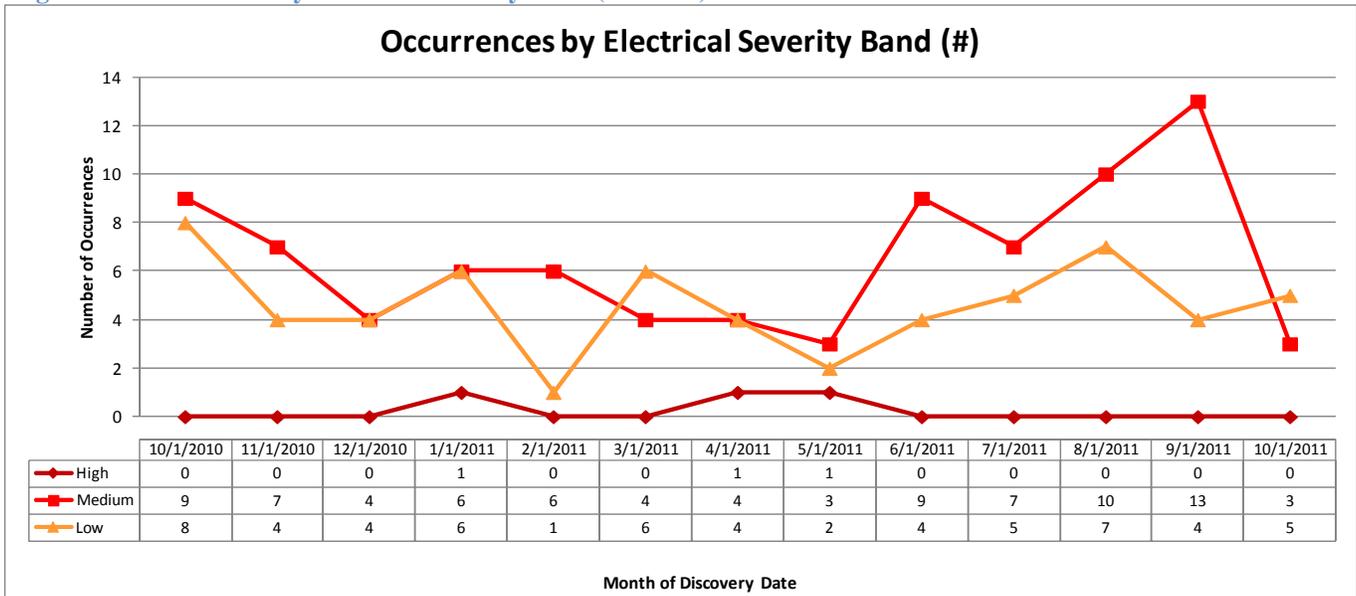
Figure 8 - Occurrences by Electrical Severity Band (Number)

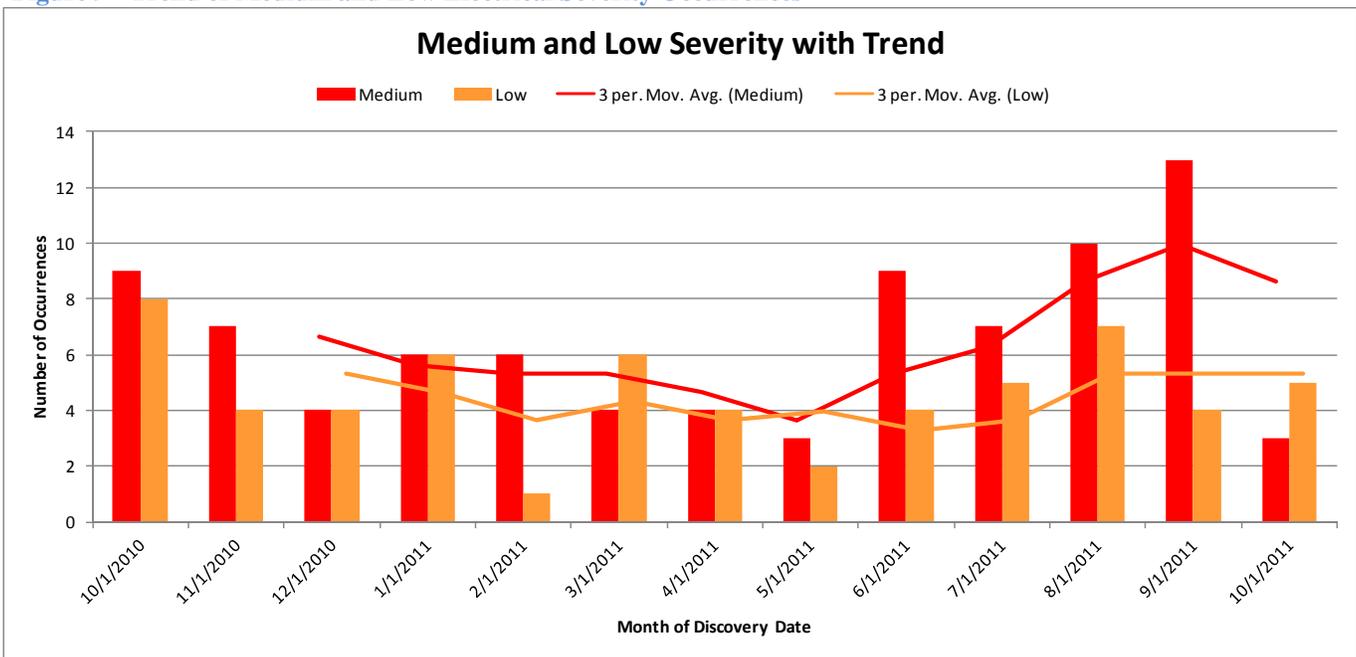
Figure 9 focuses on the Medium and Low severity data series for October 2010 through October 2011. Trend lines are included for each, using a 3-month moving average.

Figure 9 - Trend of Medium and Low Electrical Severity Occurrences

The 3-month moving average shows a decrease in the Medium severity occurrences following a steady increase since May 2011. This increase relates to the increase in the number of electrical occurrences with Medium severity scores during the past two months. The figure also shows a leveling off of Low severity occurrences.
